CK-2021

CHEHALIS 10.6km

2014 Inspection

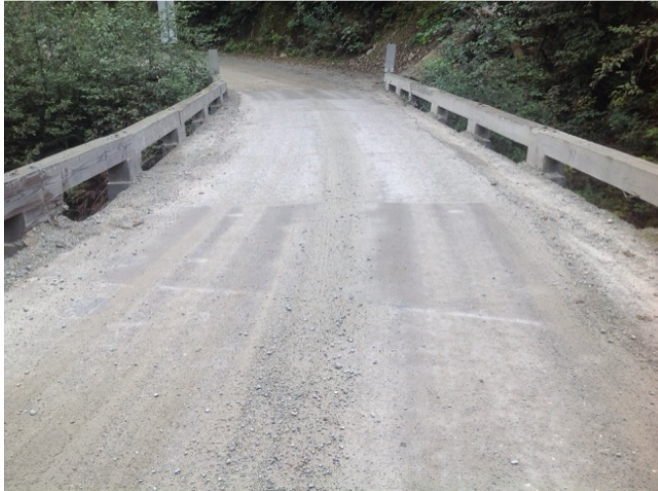
Concrete Deck Fair 7 panels, flared on downstream both approaches - skewed on left bank and on grade

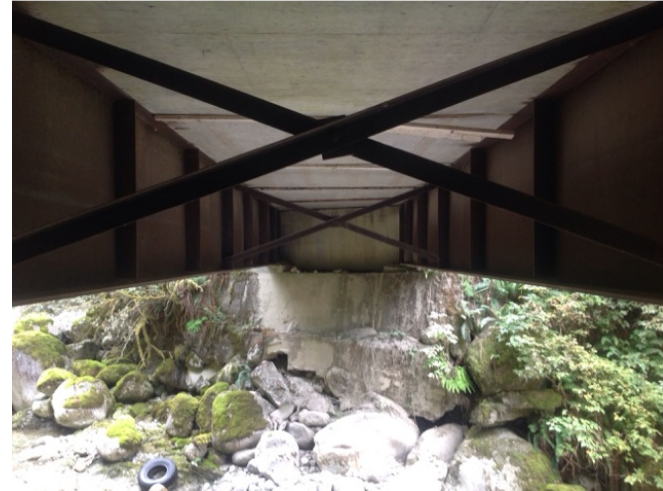
superstructure

Diaphragms Fair 2 internal only, bolted

Bracing Fair 1 set of horizontal bracing on right side

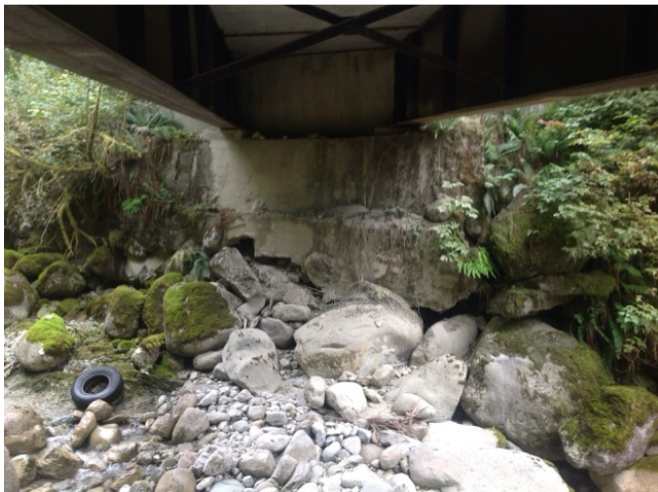
Left Bank Abutment when facing downstream

CIP left bank - some scour that should be monitored and on opposite side of stream flow

| 1 | scour under CIP abutment on left bank | Routine Inspection |

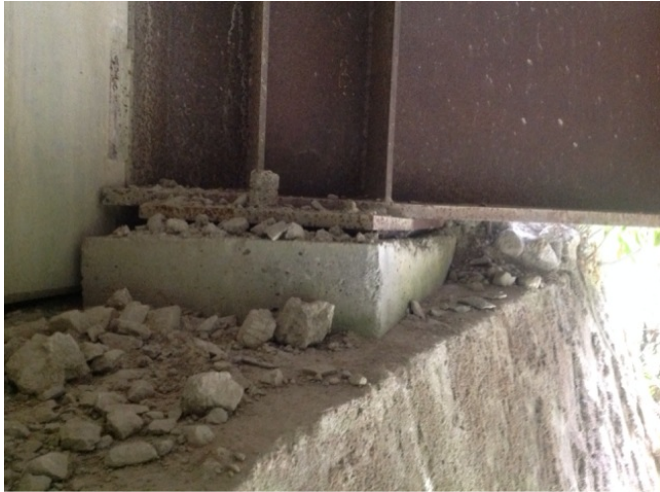
downstream left bank bearing

skewed left side

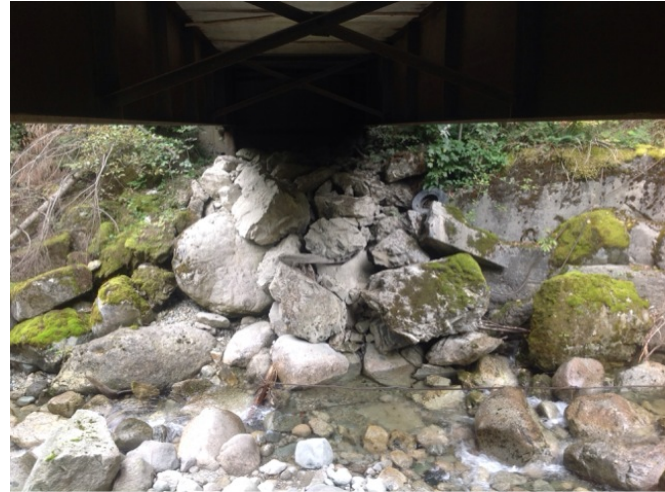
Right Bank Abutment when facing downstream

steel plates and rubber pads right bank, concrete left - old CIP on both sides still being utilized as protection from scour
