CK-2022

CHEHALIS 15.2km

2014 Inspection

## CBR Data

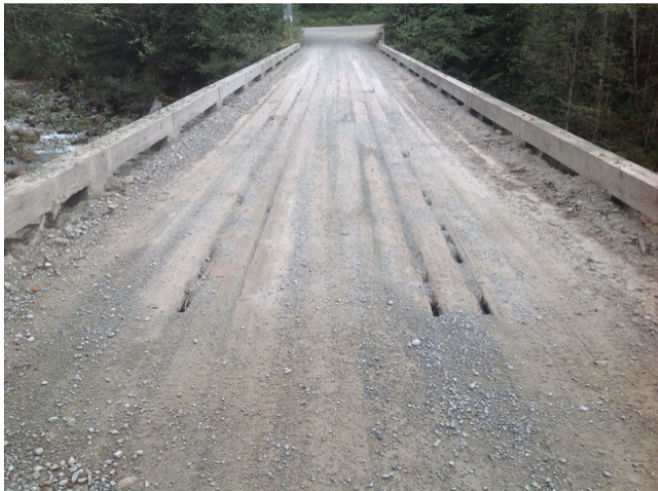
Deck

Running Planks Fair - poor fair in middle and on sides but fair to poor on wheel path - wearing through and holes starting to show

| Repair Item | Priority | Repair Description |
|---|---|---|
| 3 | High | replace rotting and worn decking on wheel path and place a wear deck top or complete replacement of existing planks |

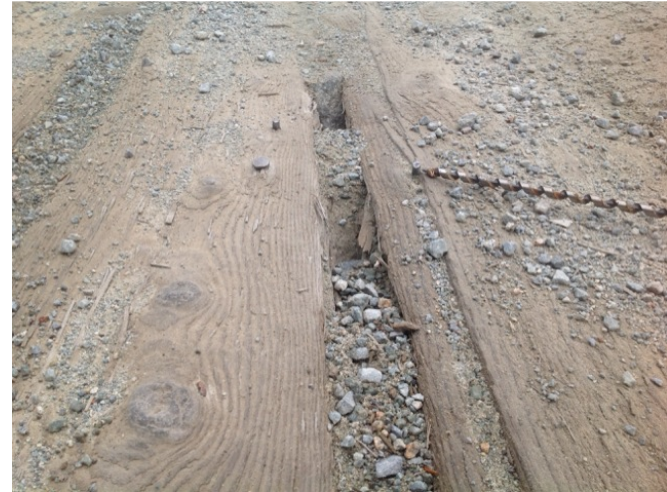
Nails Fair poor on wheel path as they are protruding in spots

nails starting to protrude

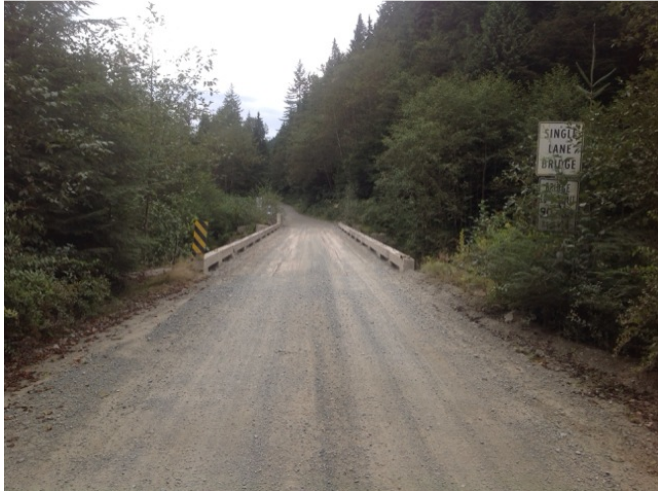
Approach from Left Bank when facing downstream

left approach fenders low - consider replacing with larger diameter logs

| Repair Item | Priority | Repair Description |
|---|---|---|
| 2 | High | replace sinking fenders on left approach |

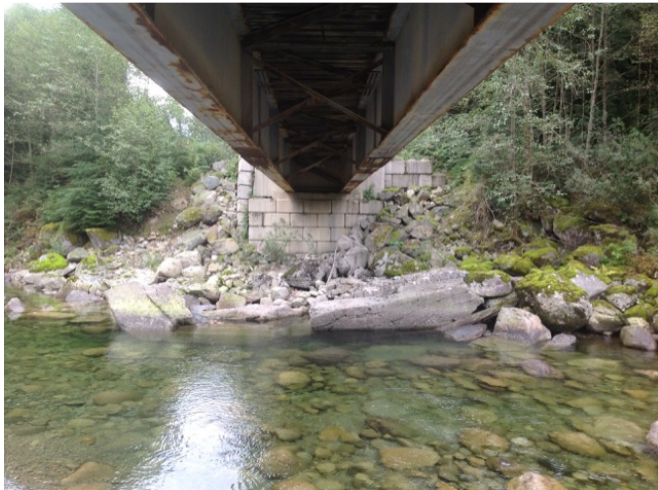
Right Bank Abutment when facing downstream

old CIP left side, newer lock blocks right side - 4 rows with CIP levelling pad

rubber pads on right bearing have slight bulging

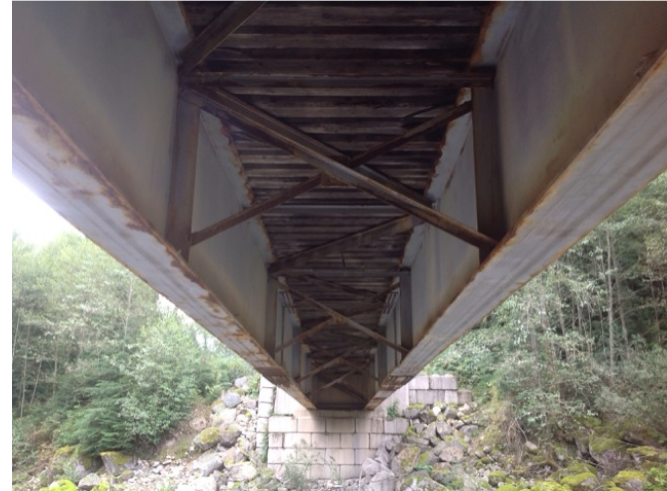
superstructure

| Girders | Fair | painted and spliced |
| Diaphragms | Fair | 6 bays, welded - left end delaminating |

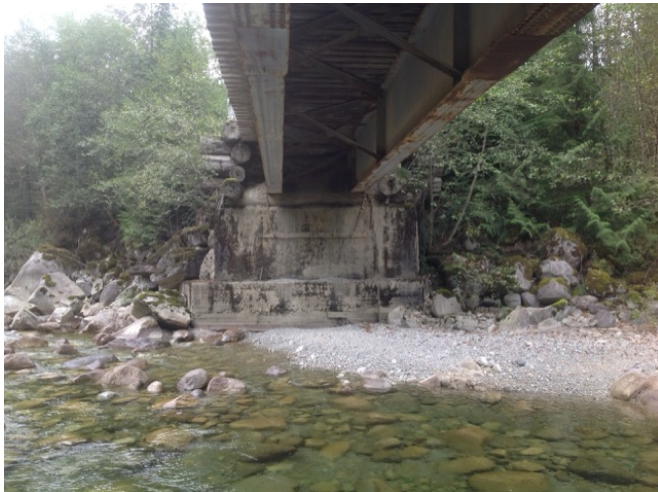
Left Bank Abutment when facing downstream

The deck is nearing the end of its industrial life - appears to be 7-8 years old and replaced at the time the town (right) abutment work was completed. The running planks are in poor shape, especially in the truck wheel path location. The woods (left) abutment requires periodic inspection, especially when active, noting upstream scour and CIP condition. Short term repair is to replace worn planks and place wear strips on top or a complete replacement of the existing planks. Replace missing delineators and replace left approach fenders with larger diameter logs. Monitor left abutment. The present load rating of L100 or 91 tonnes can continue with the deck repairs noted.

| 1 | left abutment | Anually |
