CK-2025

CHEHALIS 26.4km

2014 Inspection

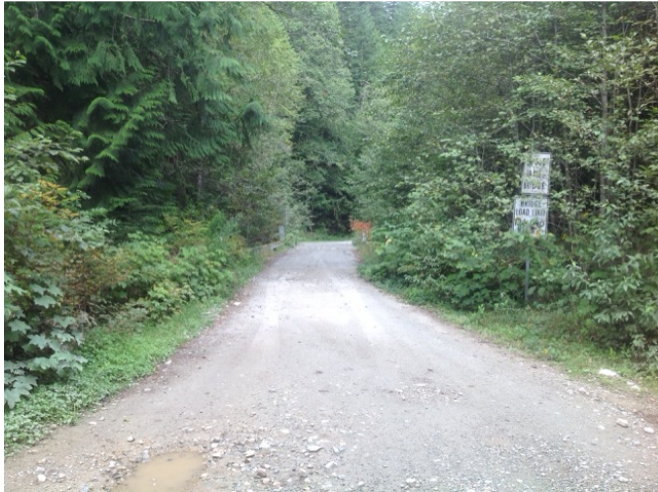
Approach from Right Bank when facing downstream

Road Surface Poor large potholes

| Repair Item | Priority | Repair Description |
|---|---|---|
| 3 | High | grade road with activity |

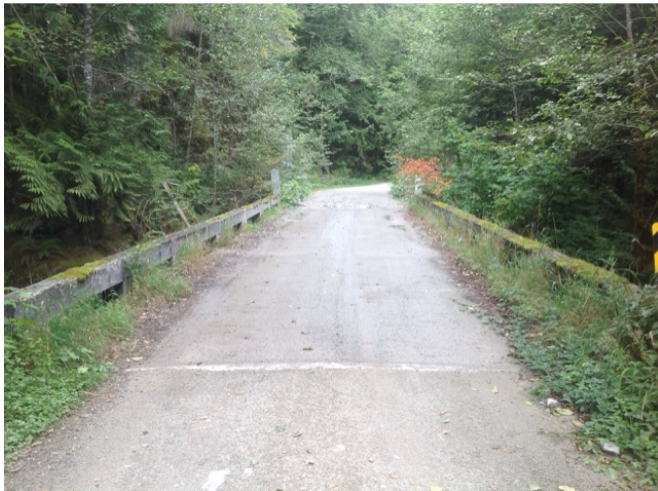
Curb Rail/Blocks/Posts    Poor    rotten risers and blocks

Hardware    Poor    loose rail bolts

Overall Deck Condition    Poor    due to rail

| Repair Item | Priority | Repair Description |
|---|---|---|
| 1 | High | replace guardrail, risers and blocks |

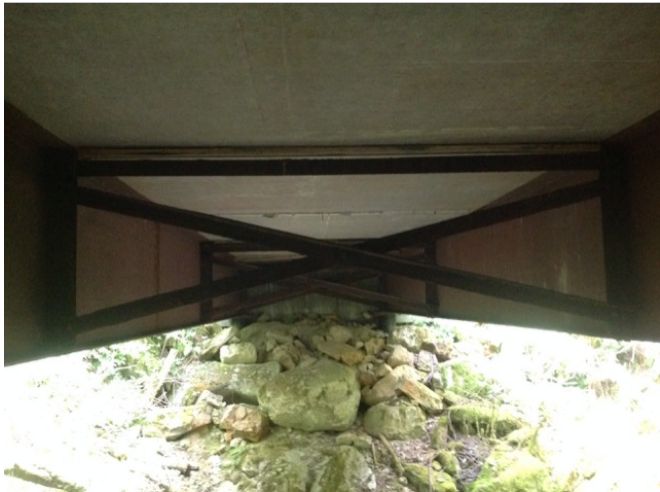
superstructure

Girders    Good

Diaphragms    Good            4 bays, bolted
