CK-2026

CHEHALIS 27.4km

2014 Inspection

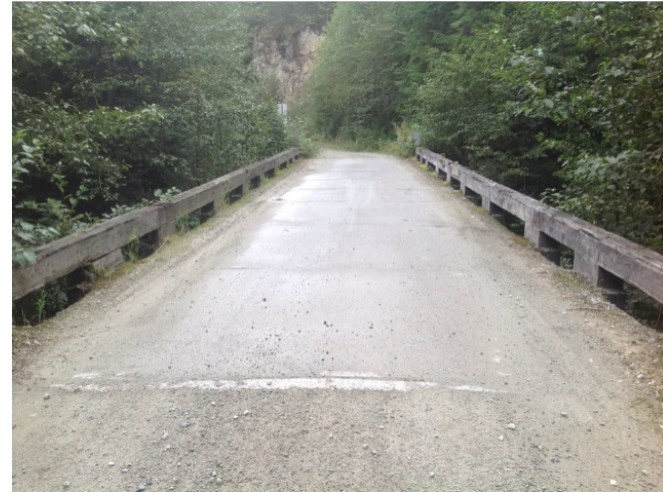
Concrete Deck Fair 8 panels

Curb Rail/Blocks/Posts Poor rotten risers and blocks

Hardware Poor loose rail bolts

Overall Deck Condition Poor due to rail

| Repair Item | Priority | Repair Description |
|---|---|---|
| 2 | High | replace guardrail, risers and blocks |

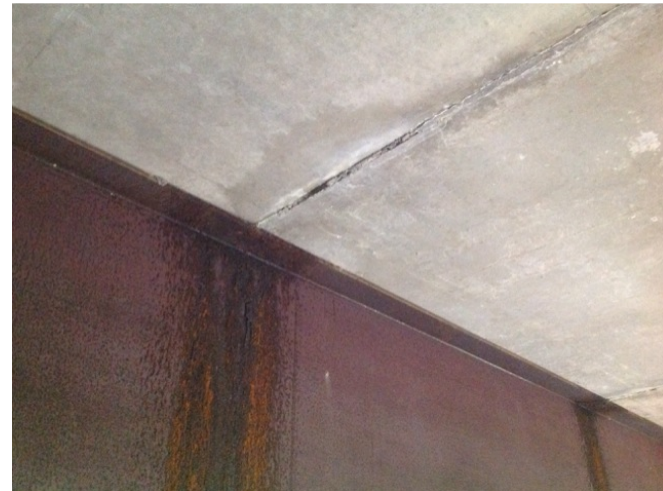
Deck joints from below

Deck Joints Fair moisture noted underneath, deck joints not grouted all the way the surface so water holds in these areas

| 2 | deck joints | annually |

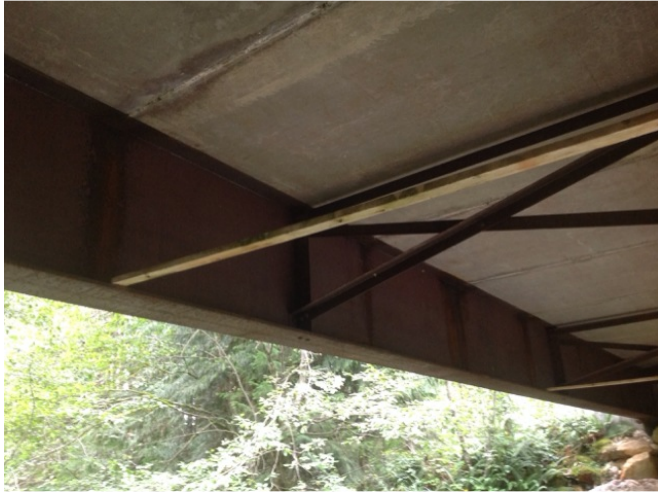
Girders Fair minor corrosion noted on downstream girder at deck joints

deck joints from below - note corrosion on girders in these locations

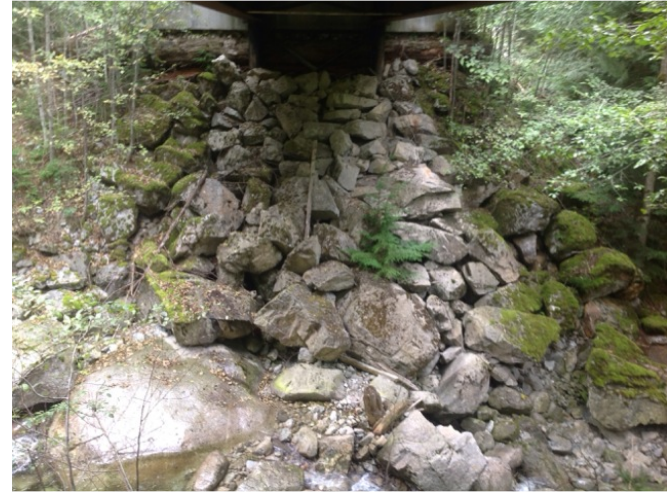
Left Bank Abutment when facing downstream

Fill Fair log under left ballast wall supporting fill is rotting

| 1 | log retaining fill on left abutment | Routine Inspection |

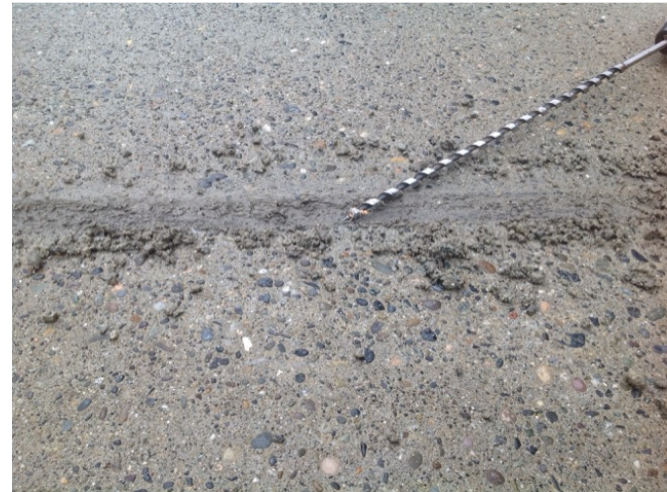
deck joints not filled right to surface - 10mm below
