CK-2027

CHEHALIS 30.8km

2014 Inspection

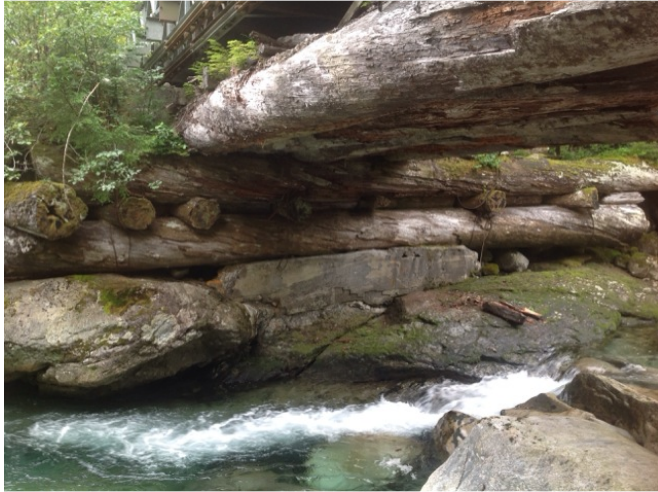
Log/Timber Cribs Fair fair to poor and only for fill retention

Right Bank Abutment when facing downstream - old crib retaining fill

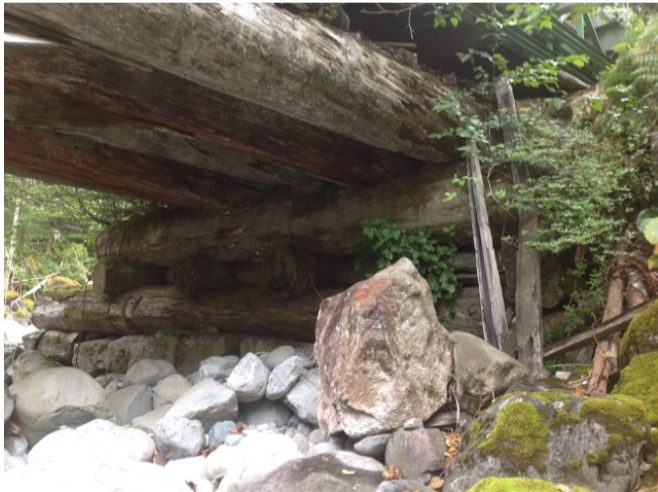
Left Bank Abutment when facing downstream - old crib retaining fill

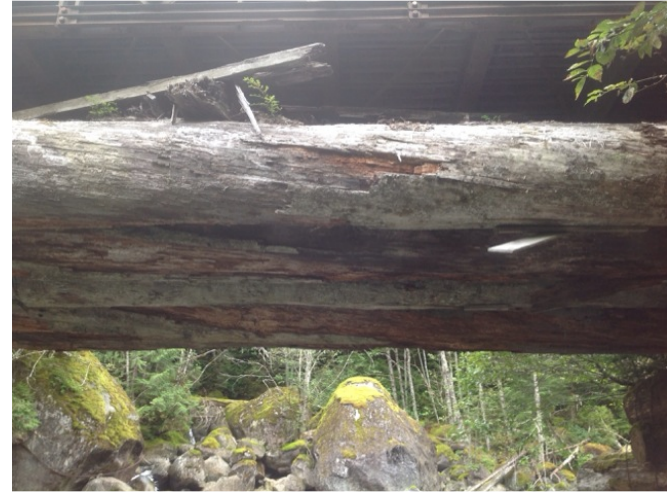
old log stringers underneath

1 log stringers for failure
