CK-2033

CHEHALIS-STATLU 6km

2014 Inspection

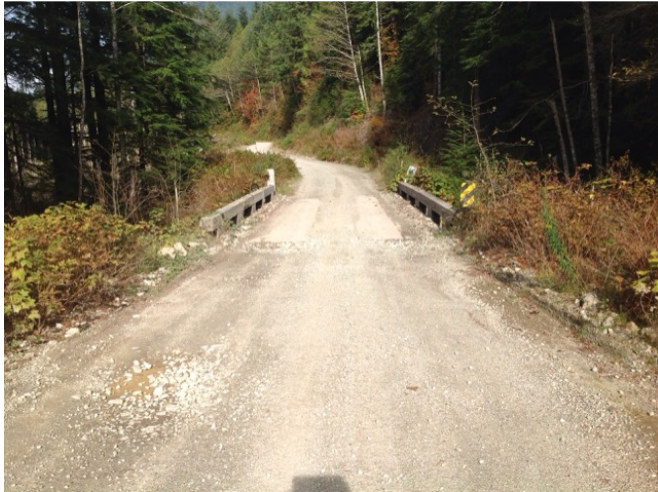
Approach from Left Bank when facing downstream

Delineator Missing  
Left ☐ 0 ☒ 1 ☐ 2Delineator Missing  
Right ☒ 0 ☐ 1 ☐ 2

Fender Condition Fair missing downstream left

| Repair Item | Priority | Repair Description |
|---|---|---|
| 3 | Medium | replace missing fender downstream left approach |

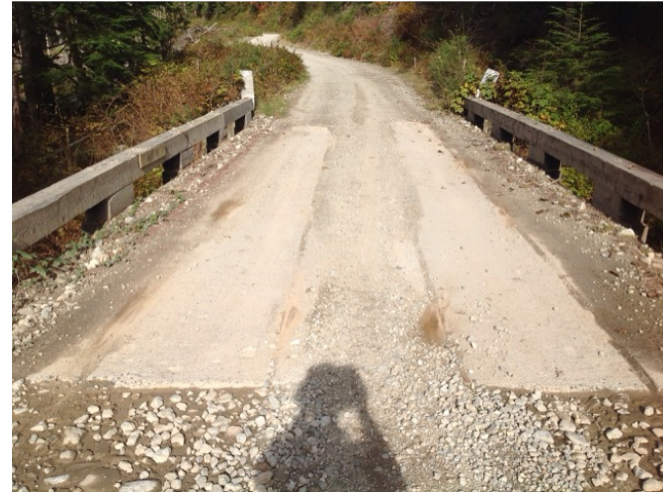
Curb Rail/Blocks/Posts   Poor   rotten blocks and rotting risers

Hardware   Poor   loose rail bolts

Overall Deck Condition   Poor   due to rail

| Repair Item | Priority | Repair Description |
|---|---|---|
| 2 | Medium | replace guardrail, risers and blocks |

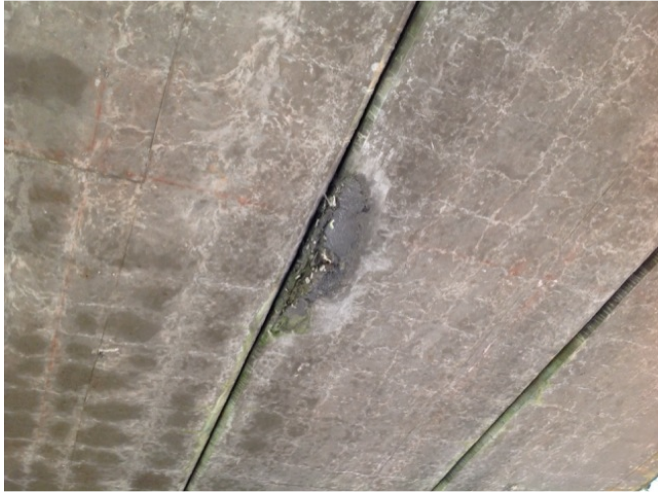
patched slab
