CK-2034

CHEHALIS-STATLU 9.7km

2014 Inspection

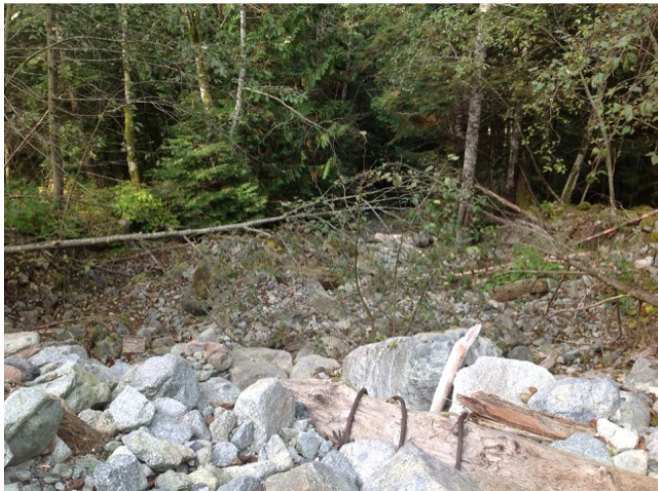
looking downstream

Comments log stringers have been removed and crossing is a ford
