CK-2038

CHEHALIS-SOUTHSTATLU 5.9km

2014 Inspection

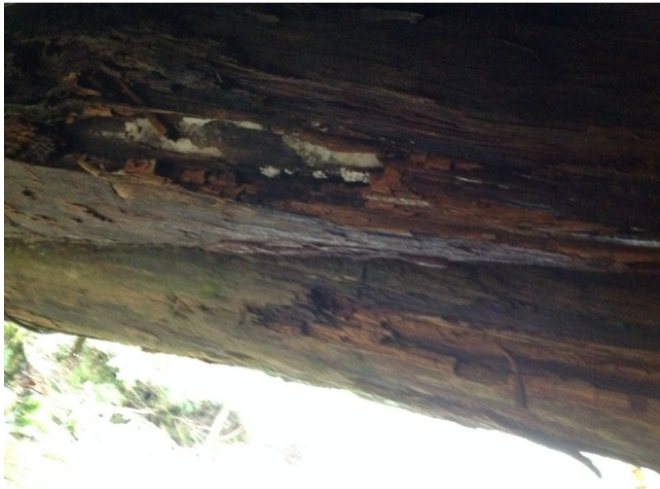
Comments 4 large diameter stringers that are in poor shape  
punchon and gravel deck - everything rotten and should be removed  
right bank dry to deactivate  
11.0 meter span

Structure condemned - 0 tonnes load rating. Remove and block access.
