CK-2042

CHEHALIS-FLEETWOOD 4.3km

2014 Inspection

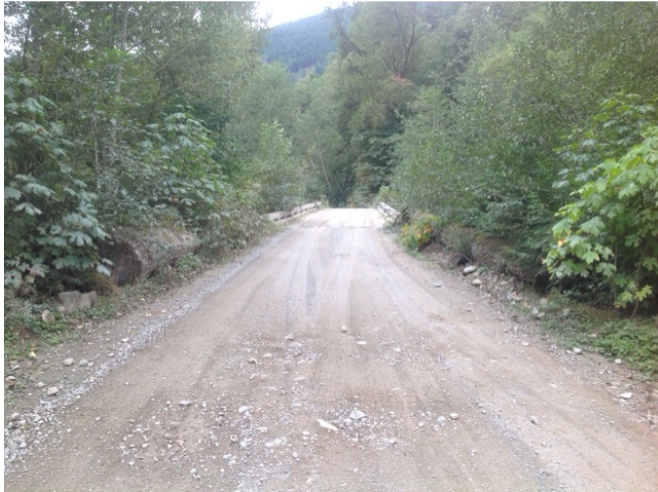
Approach from Left Bank when facing downstream

Bridge Ahead Signs  
Missing ☐ 0 ☐ 1 ☒ 2

Delineator Missing  
Left ☐ 0 ☐ 1 ☒ 2

| Repair Item | Priority | Repair Description |
|---|---|---|
| 2 | Medium | replace missing delineators and bridge ahead signs |

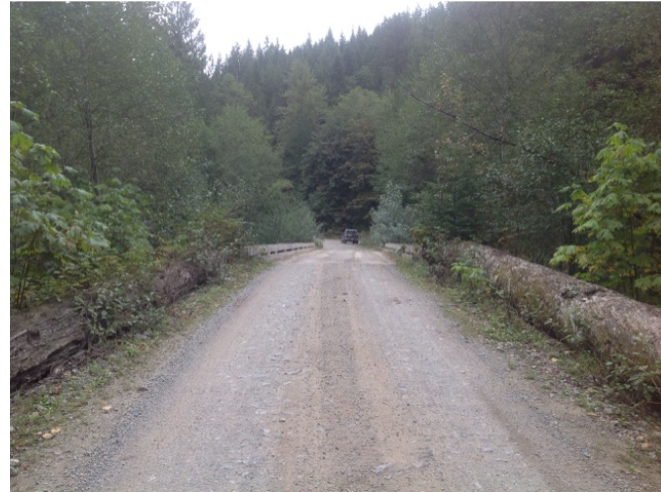
Approach from Right Bank when facing downstream

Delineator Missing  
Right ☐ 0 ☒ 1 ☐ 2

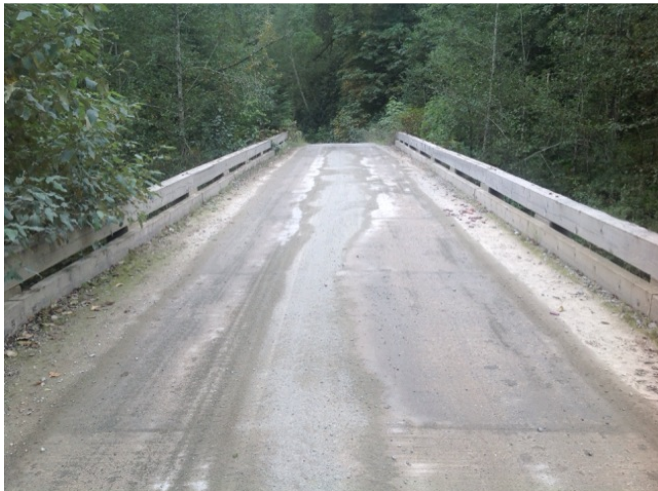
Overall Deck Condition Fair

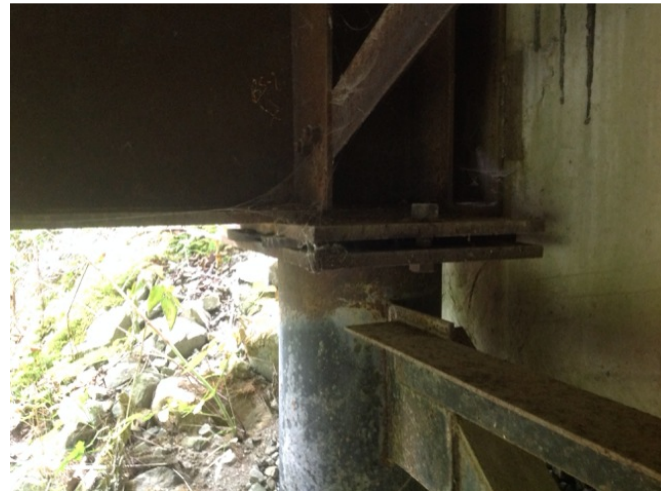
downstream right bearing pads

Bearings Fair

1 bearing pads

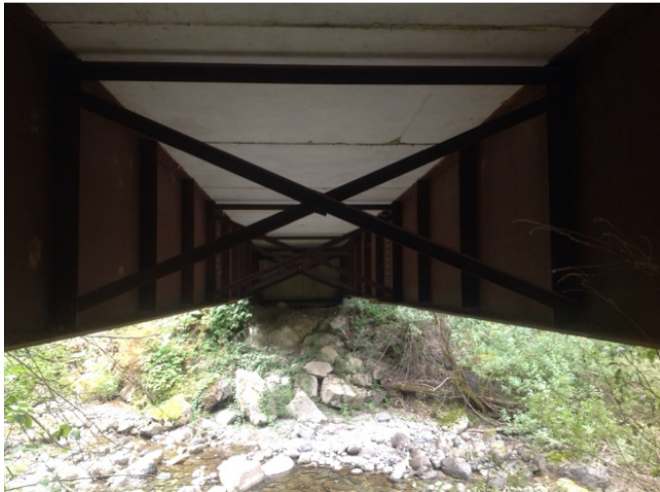
superstructure

Girders    Good

Diaphragms    Good            5 bays, bolted
