CK-2045

CHEHALIS-MYSTERY km

2014 Inspection

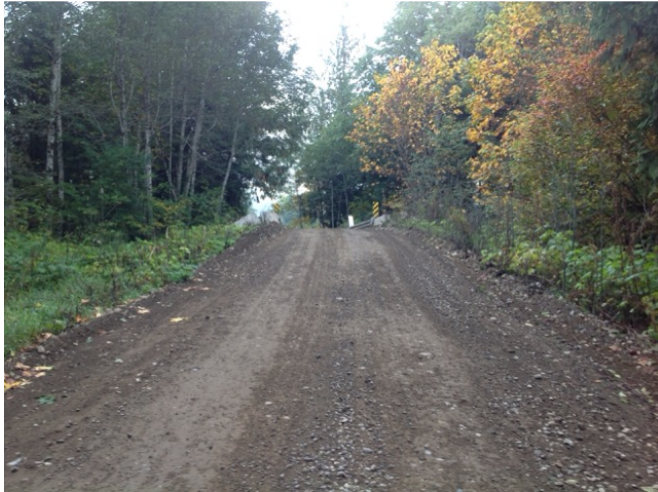
Approach from Left Bank when facing downstream

part of no posts pushed off road

Replace concrete no post barriers at left approach as they have been pushed off the road. Post bridge ahead signs. Present load rating of L75 or 68 tonnes to continue.

| Repair Item | Priority | Repair Description |
|---|---|---|
| 2 | Medium | replace no posts on left approach that have been pushed off road |

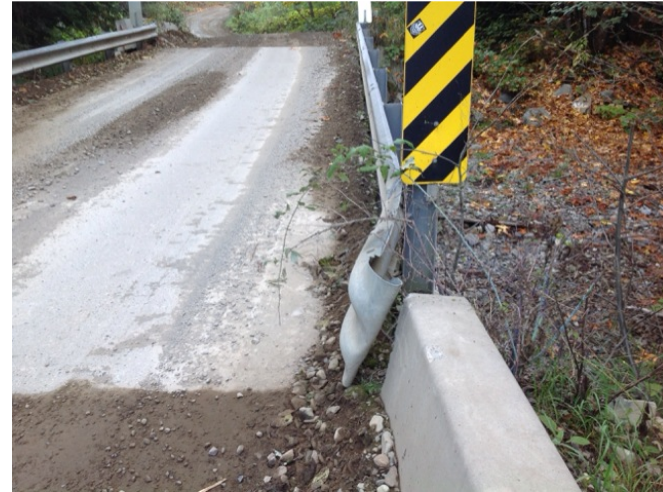
Curb Rail/Blocks/Posts   Fair   minor damage upstream left approach

guardrail damage

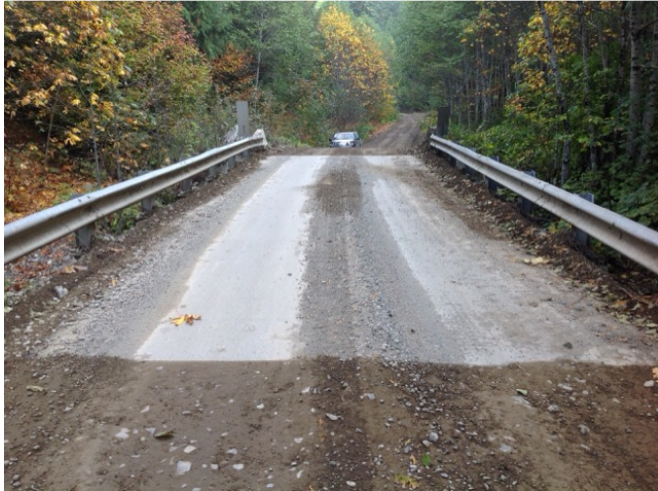
Concrete Deck   Fair   minor track damage
