2046

CHEHALIS-MYSTERY km

2014 Inspection

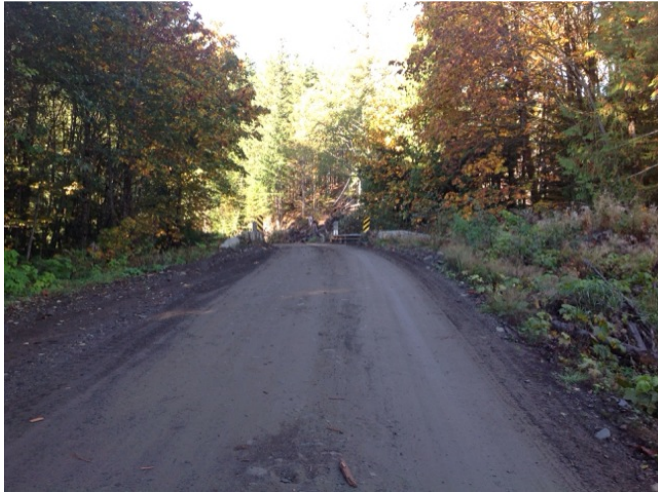
Approach from Left Bank when facing downstream

Bridge Ahead Signs  
Missing ☐ 0 ☐ 1 ☒ 2

| 1 | Medium | post bridge ahead signs |

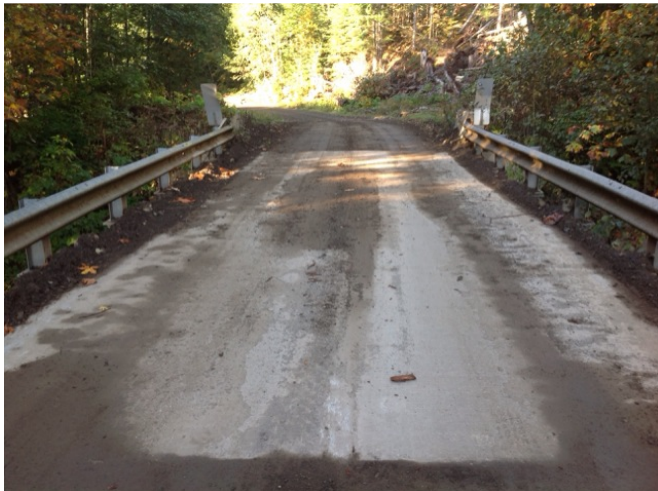
Concrete Deck   Fair   track damage

Overall Deck Condition   Fair
