CK-2048

CHILLIWACK RIVER 1km

2014 Inspection

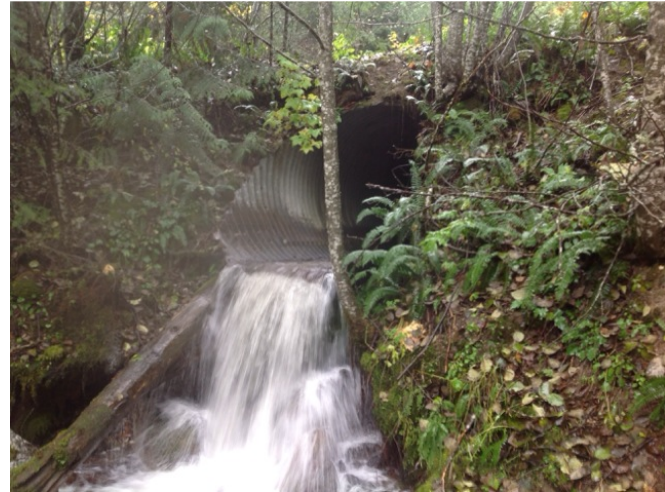
Outlet Fair 2m drop

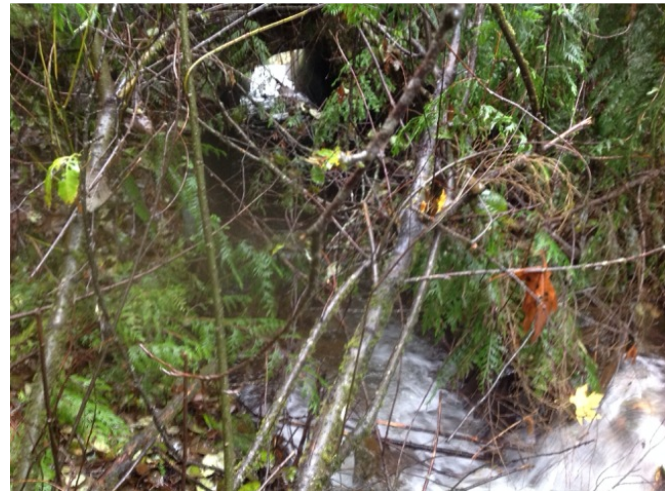
Inlet Fair
