CK-2052

CHILLIWACK RIVER 11.1km

2014 Inspection

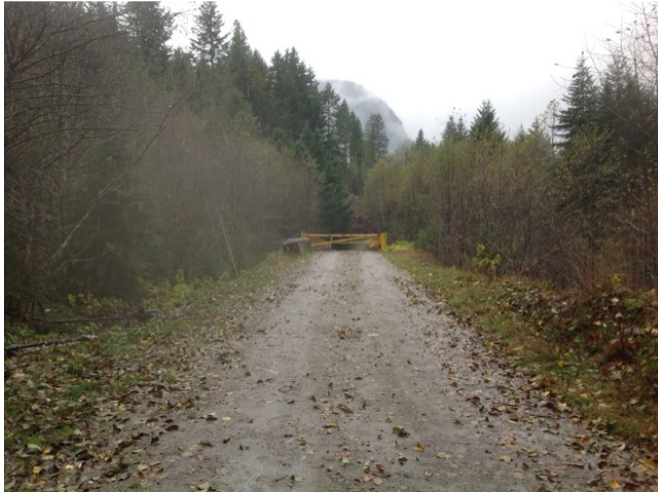
Approach from Right Bank when facing downstream

Fender Condition Poor missing right approach and ineffective left approach

| 3 | | place fenders at approaches |

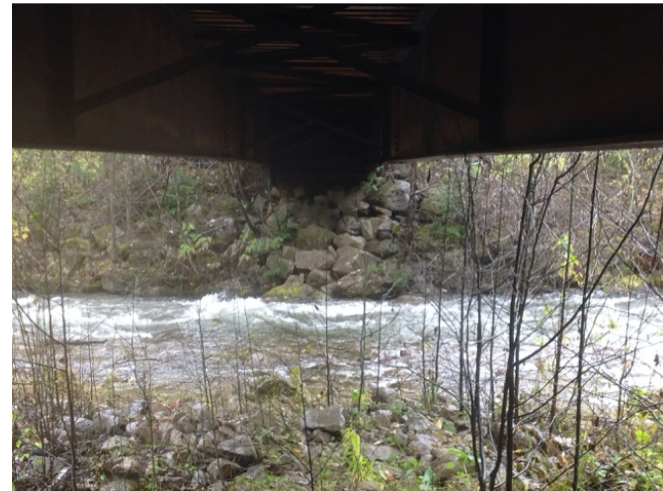
Right Bank Abutment when facing downstream

Wing Wall Poor ends of wing rotten but still retaining fill

| 1 | condition of wingwalls |
