CK-2076

FOLEY CREEK 4.4km

2014 Inspection

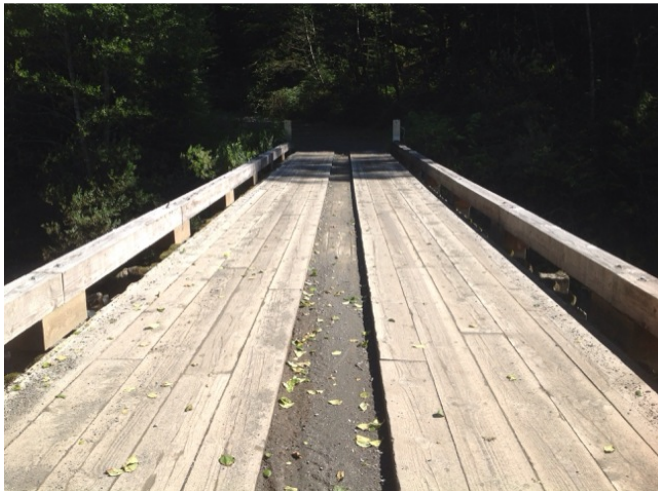
Overall Deck Condition Good

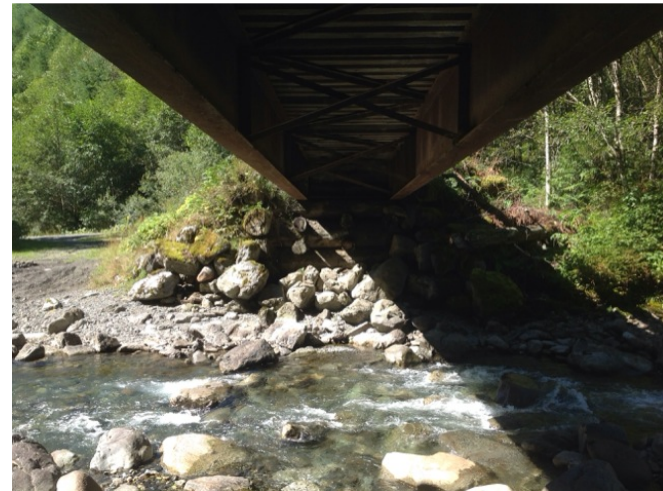
Right Bank Abutment when facing downstream

Log/Timber Cribs Fair 4x left abutment and 3x right abutment

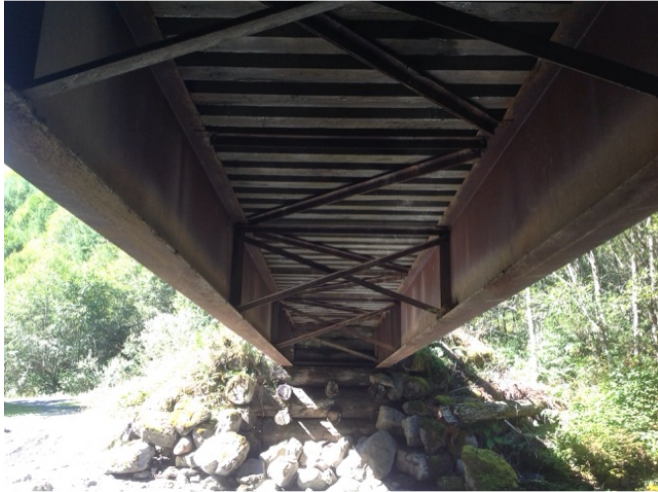
superstructure

Girders Fair

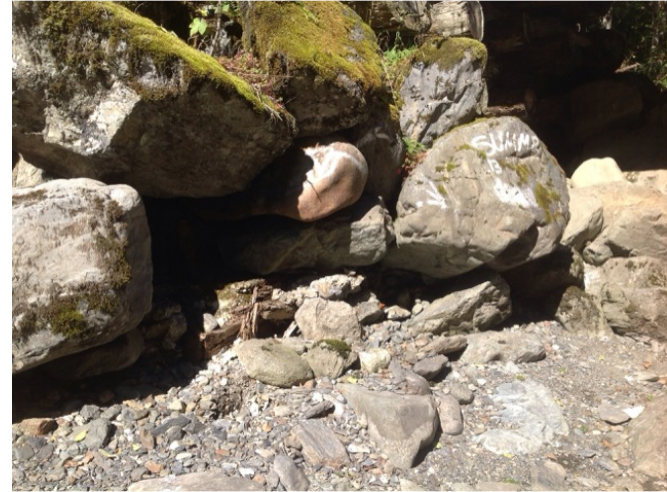
Comments scour noted downstream right side

downstream right abutment scour

Post bridge ahead signs and monitor riprap/abutment scour at downstream right side. Present load rating of L60 or 54 tonnes to continue.
