CK-2077

AIRPLANE CREEK 0.1km

2014 Inspection

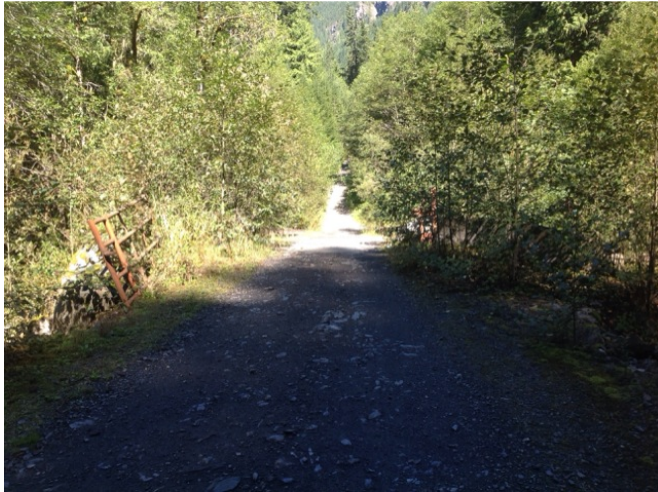
Bridge Ahead Signs  
Missing ☐ 0 ☐ 1 ☒ 2

Brushing Required Y

Delineator Missing  
Left ☐ 0 ☐ 1 ☒ 2Delineator Missing  
Right ☐ 0 ☐ 1 ☒ 2

Approach from Left Bank when facing downstream

| Repair Item | Priority | Repair Description |
|---|---|---|
| 1 | Medium | replace missing delineators and bridge ahead signs |
| 2 | Medium | brush approaches |

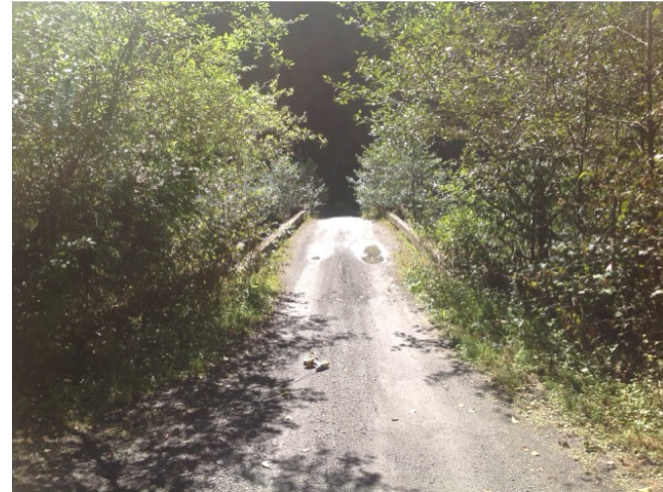
Approach from Right Bank when facing downstream

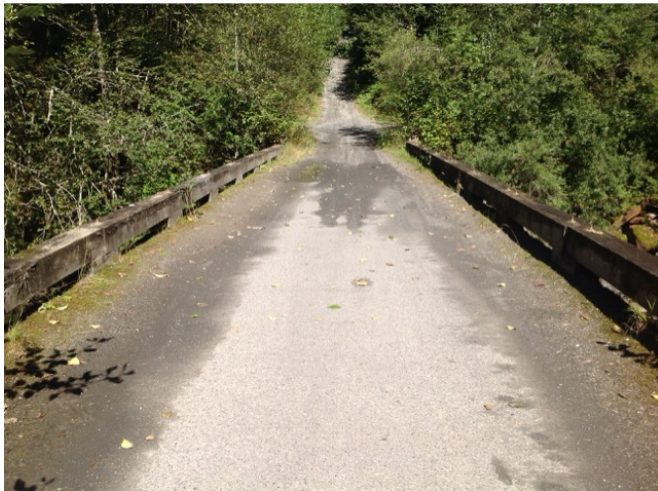
Running Surface Fair lots of sediment on deck

Welded/grouted shear connectors Fair asphalt overlay

Deck - asphalt cover

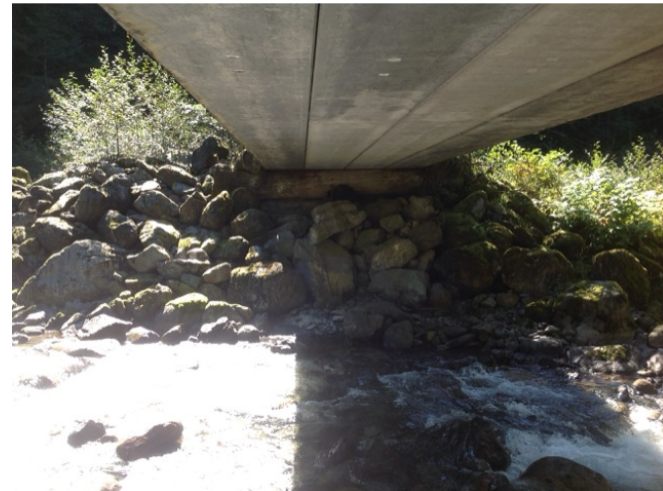
Log/Timber Cribs Fair 5x on right bank and 2x left bank - closed face

Left Bank Abutment when facing downstream

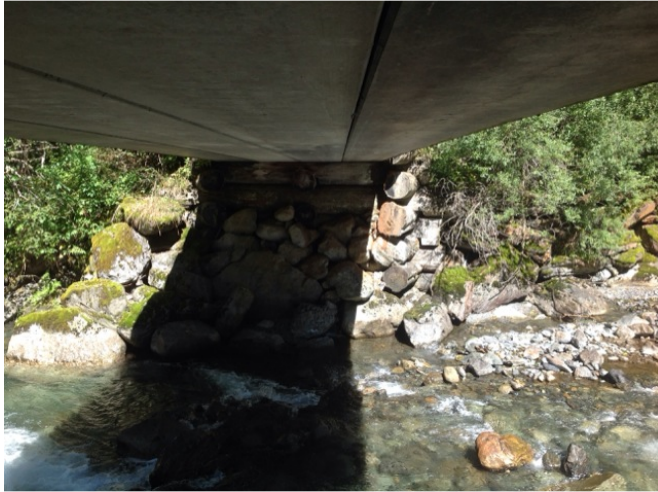
Right Bank Abutment when facing downstream
