CK-2085

CHILLIWACK SOUTH 0.1km

2014 Inspection

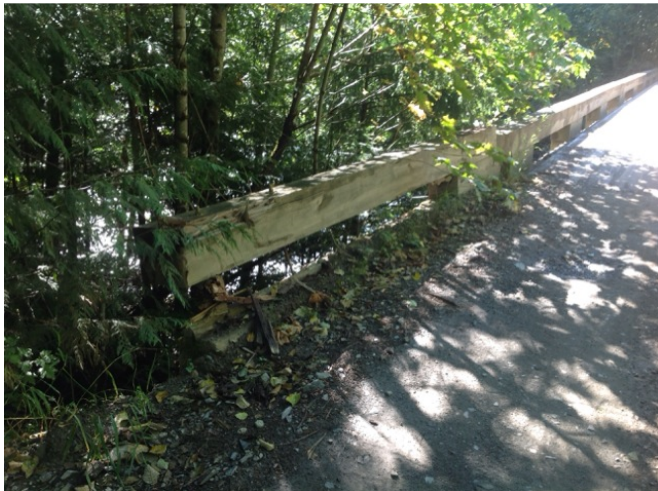
Guard Rail extension onto wing wall on right upstream end

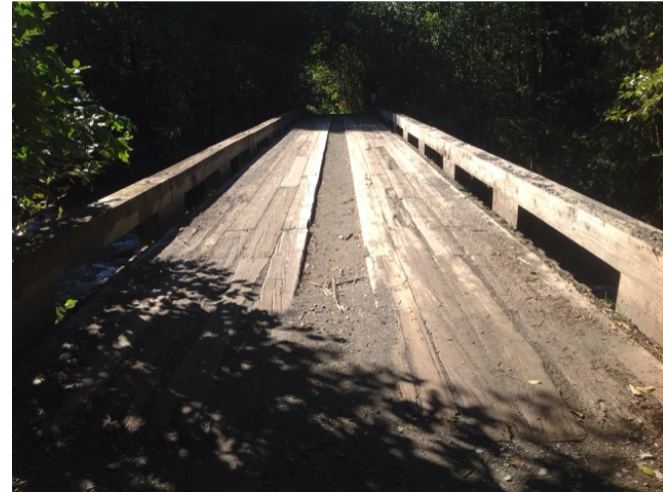
Deck

Running Planks Fair fair to poor as some planks have extensive wear

| Repair Item | Priority | Repair Description |
|---|---|---|
| 1 | Medium | recommend replacing all wear planks |

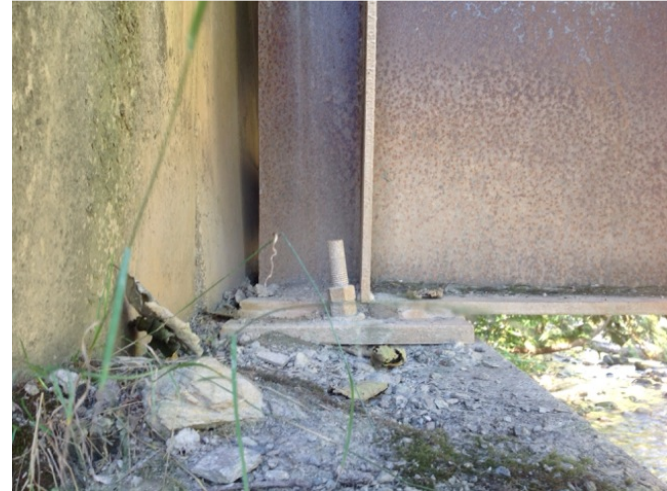
upstream left bearing bolts

Bearings Fair monitor bearing bolts on left abutment

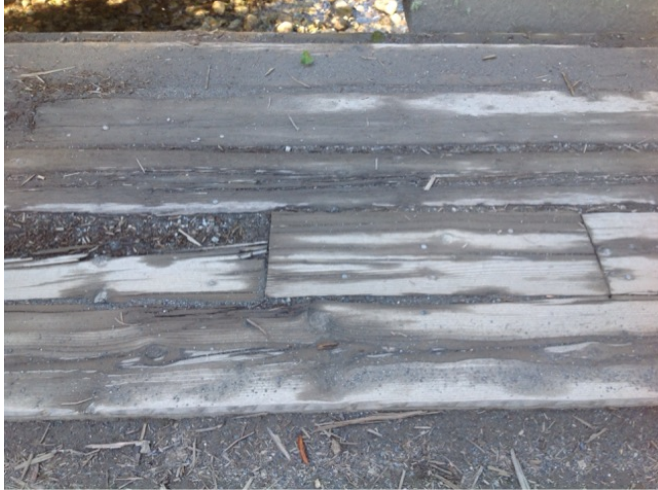
past wear plank replacement
