CK-2092

FLORENCE LAKE 4.2km

2014 Inspection

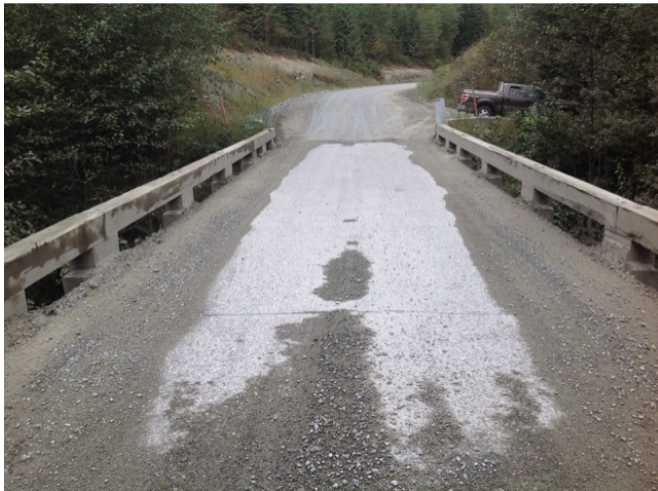
Overall Deck Condition Fair

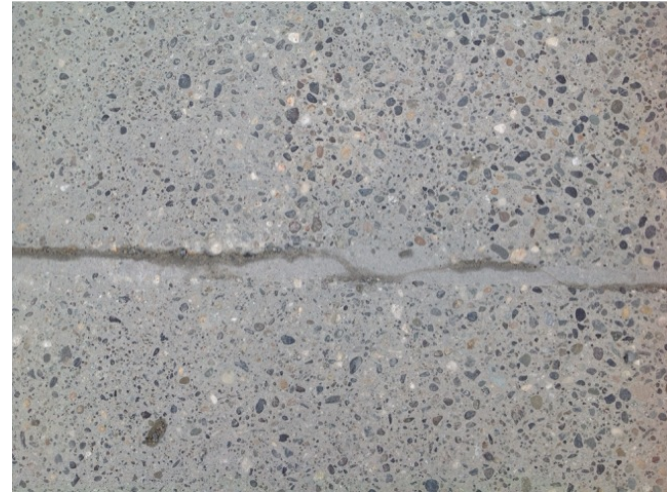
Deck Joints Fair cracks noted however no moisture noted getting through

cracks in deck joints

1 deck joints
