CK-2094

FLORENCE LAKE 7.8km

2014 Inspection

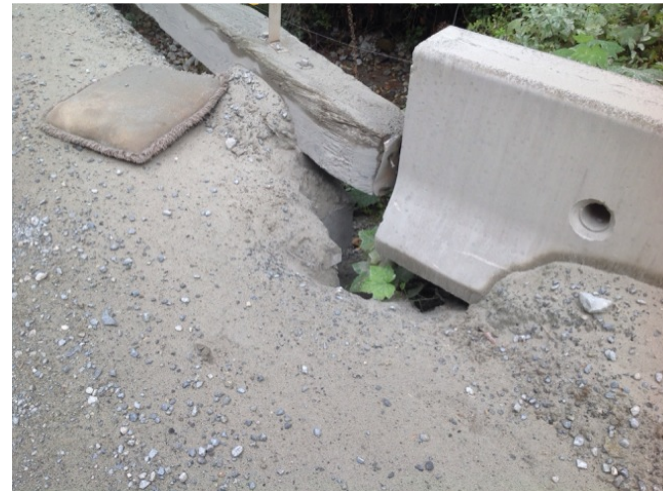
Fill Fair eroding at approaches

fill erosion left upstream approach

Monitor fill at approaches. Present load rating of L60 or 54 tonnes to continue.

1 eroding fill at road edges

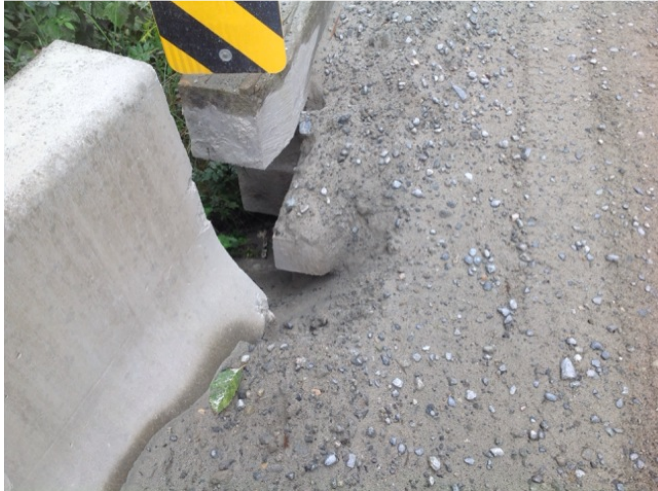
fill erosion left downstream
