CK-2095

FLORENCE LAKE 9.4km

2014 Inspection

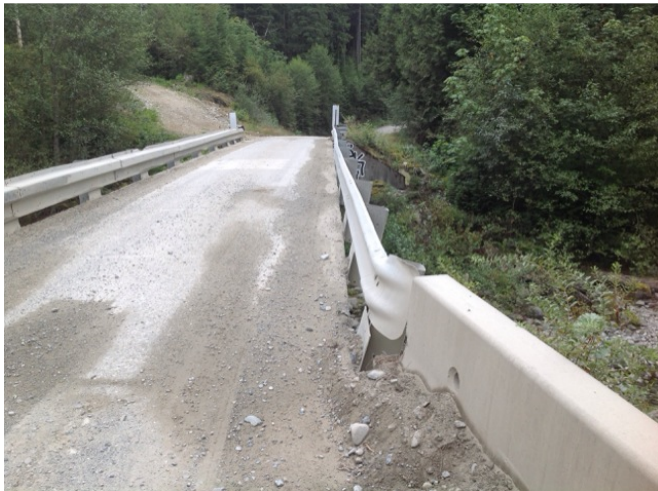
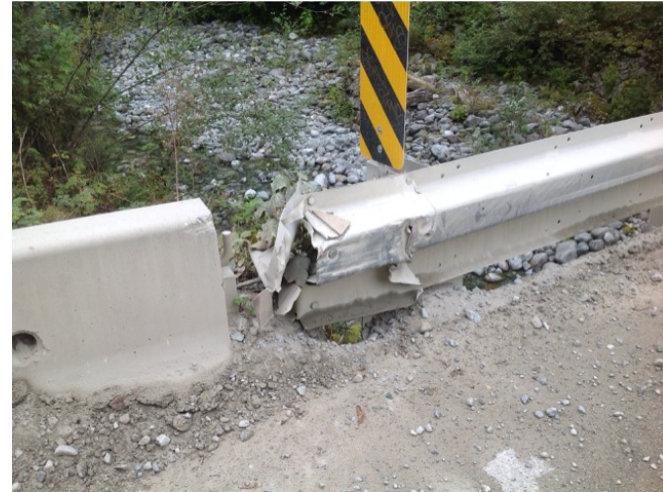
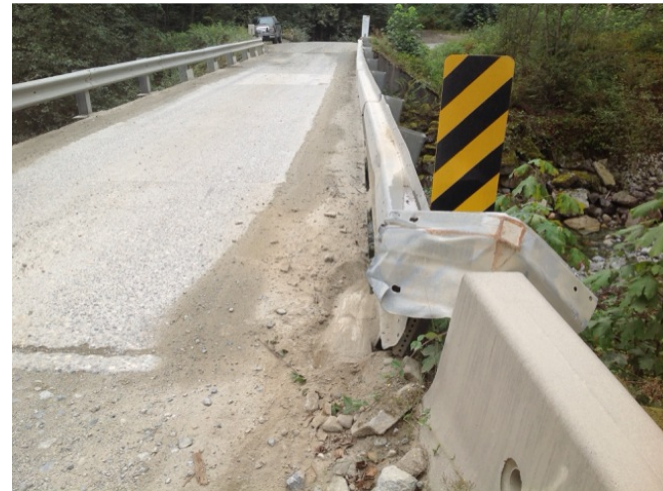
Guard Rail

Curb Rail/Blocks/Posts Fair both rails have sustained minor damage but still functional

1 guardrail condition

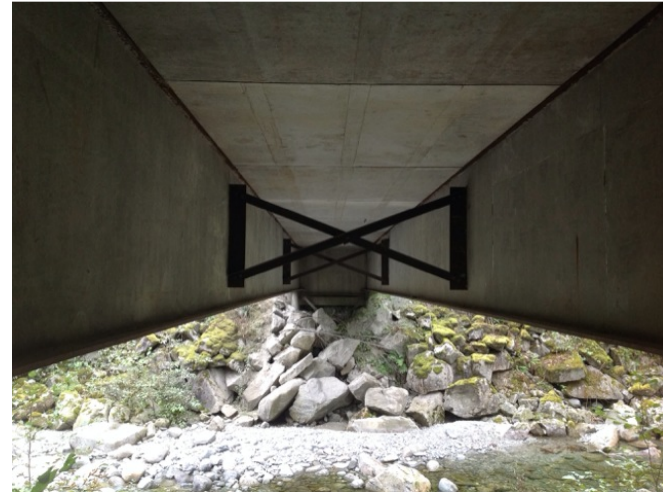
superstructure

| Girders | Fair | 2 compo girders with hairline cracks |
