CK-2097

FLORENCE LAKE 13.6km

2014 Inspection

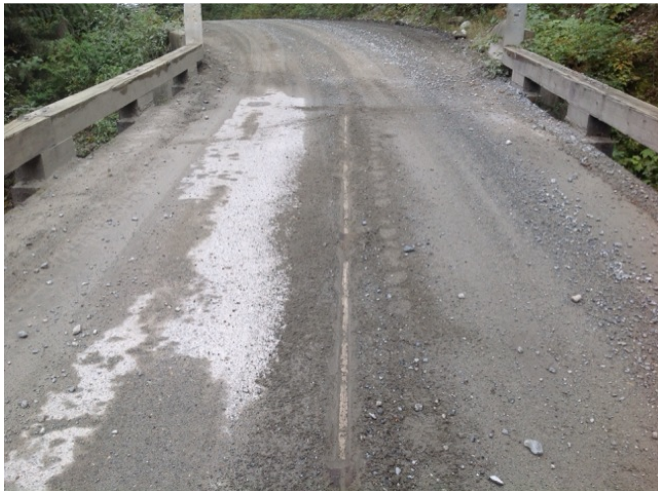
Concrete Deck Fair

Overall Deck Condition Fair
