CK-2098

FLORENCE LAKE 13.9km

2014 Inspection

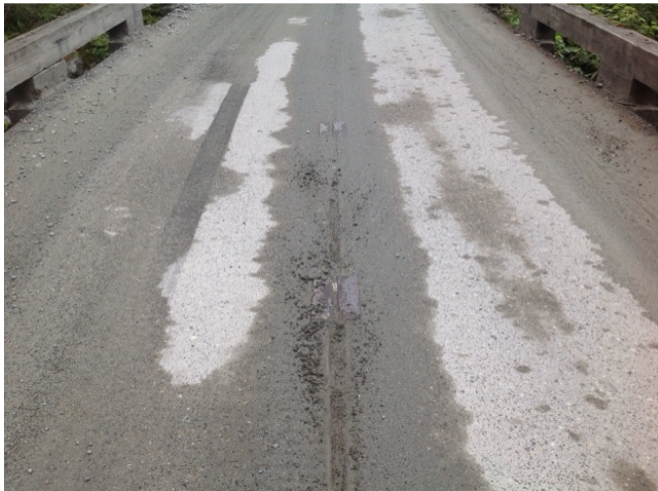
Curb Rail/Blocks/Posts Poor rotten riser and sideblocks

Hardware Poor loose rail bolts

Overall Deck Condition Poor due to rail

Replace guardrail, risers and blocks. Present load rating of L75 or 68 tonnes to continue.

| 1 | Medium | replace guardrail, risers and blocks |
