CK-2099

FLORENCE LAKE 14.1km

2014 Inspection

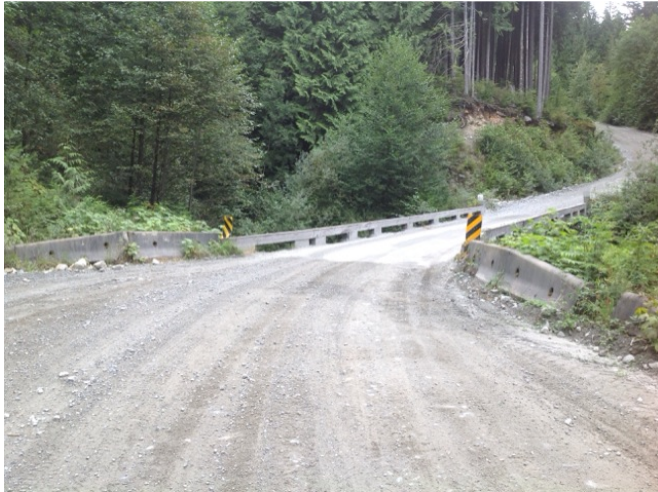
Approach from Right Bank when facing downstream

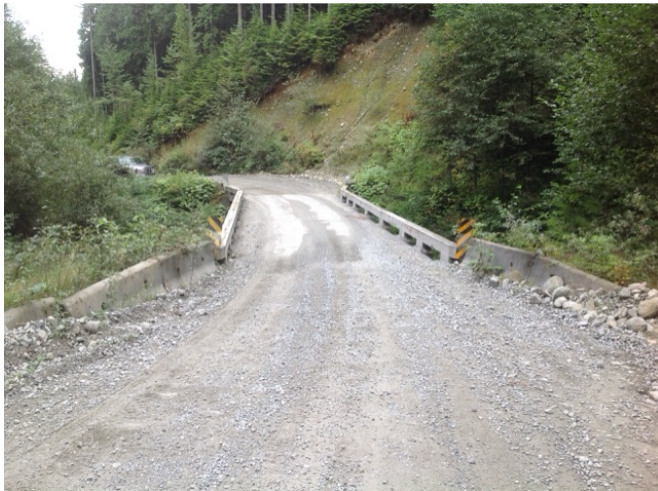
Approach from Left Bank when facing downstream

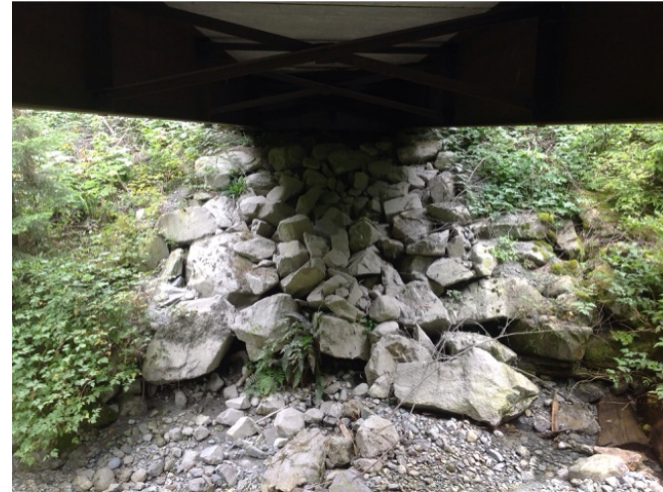
Right Bank Abutment when facing downstream

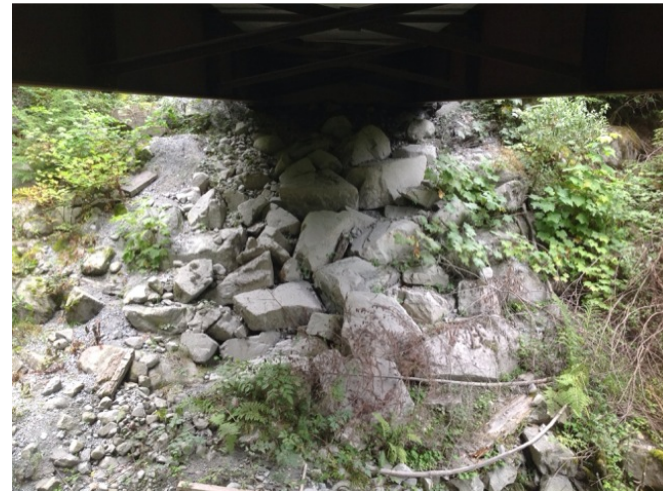
Left Bank Abutment when facing downstream
