**BC Ministry of Forests and Range**  
*Permanent Bridge Inspection Report*

| Structure #: | CK-2107 | Site #: | CK-2107 | Road Name: | HARRISON EAST | Inspection Date: | 2014/08/26 |
| KM: | 24.80 | User km: | 24.80 | Crossing Name: | Cogburn Creek | Next Inspection Date: | 2017/08/26 |

CK-2107

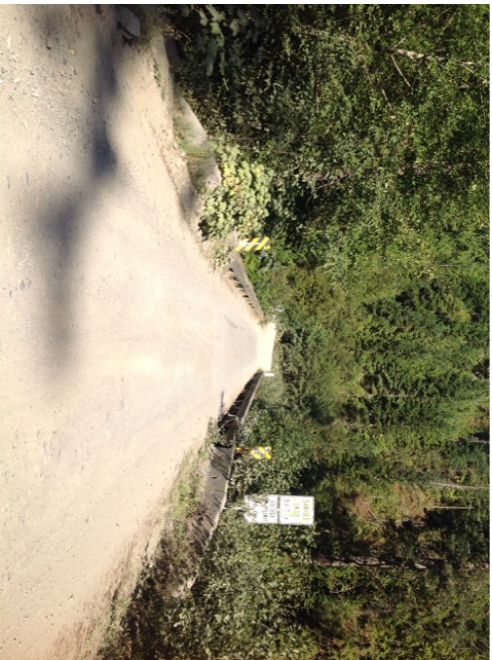
Approach from Left Bank when facing downstream

| ABUTMENTS | | |
|---|---|---|
| Brushing Required | Yes | |

| 1 | Required | Medium | \$1,000.00 | brush approaches | | | |

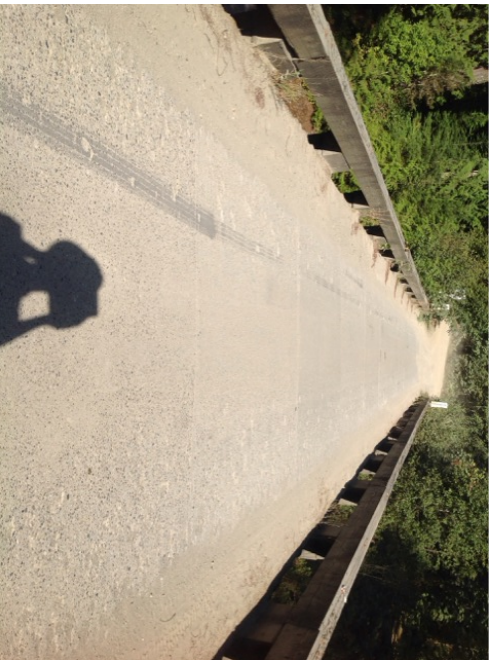
| Curb Rail/Blocks/Posts | Fair | | | sideblocks rotting and rail starting to get loose | | | |
| Overall Deck Condition | Fair | | | consider replacing guardrail, risers and blocks | | | |

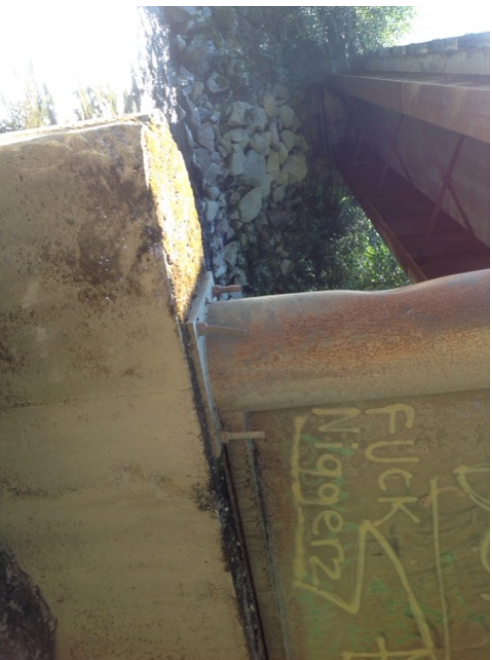
| Piles or Posts | Fair | | | impacted on upstream post - rusting at impact location - inspect again next year | | | |

| 2 | impact damage to pier on upstream post | | | | | | |

pier damage

| Inspector's Comment: | Brush approaches. Consider replacing guardrail, risers and blocks soon as rot detected in sideblocks. Monitor damage to upstream post of pier. There is rust on the impact location so damage has been here for sometime - inspect again next year. Monitor impact damage to deck at expansion joint. Present load rating of L150 or 136 tonnes to continue. | | | | | | |

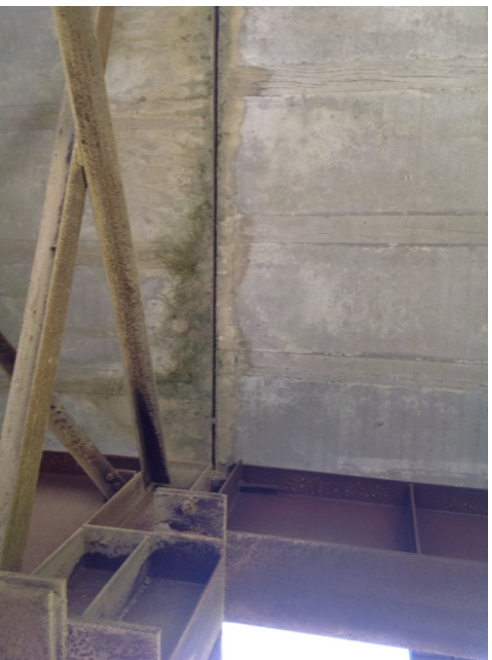
| Deck Joints | Fair | | | impact damage at expansion joint | | | |

| 1 | damage to deck at expansion joint | | | | | | |

panel damage at jumpspan
