CK-2112

HARRISON EAST 51.7km

2014 Inspection

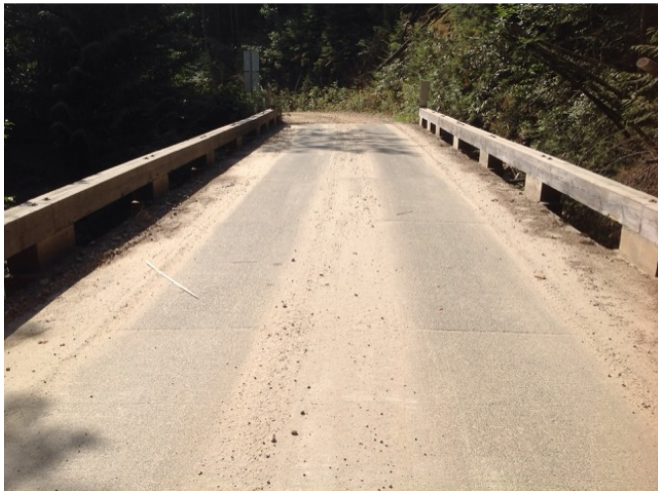
Concrete Deck    Good

Overall Deck Condition    Good

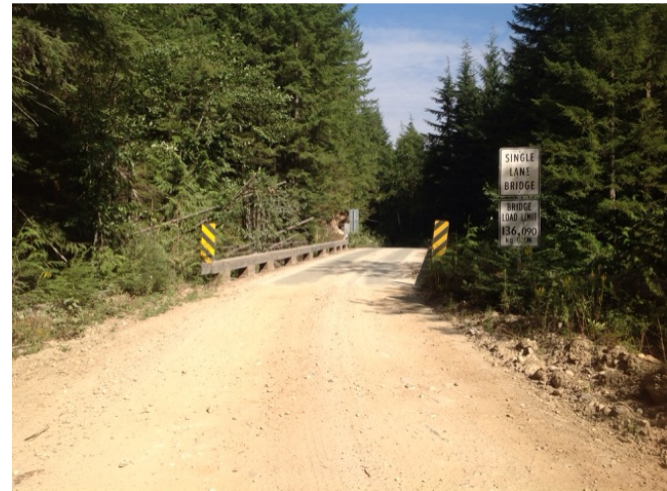
Approach from Right Bank when facing downstream

Fender Condition Fair no fender upstream right approach

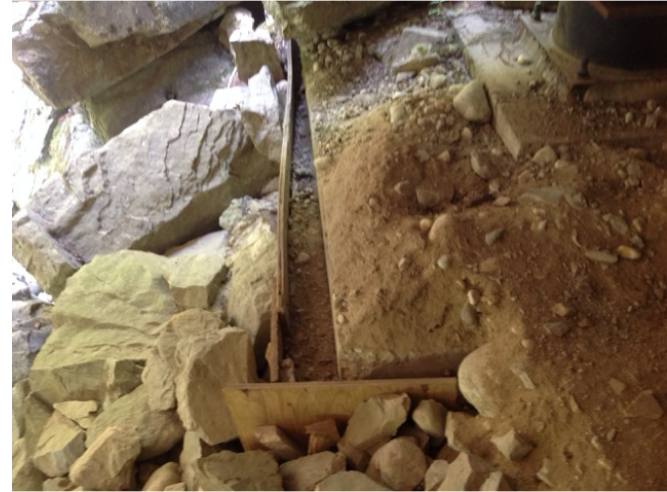
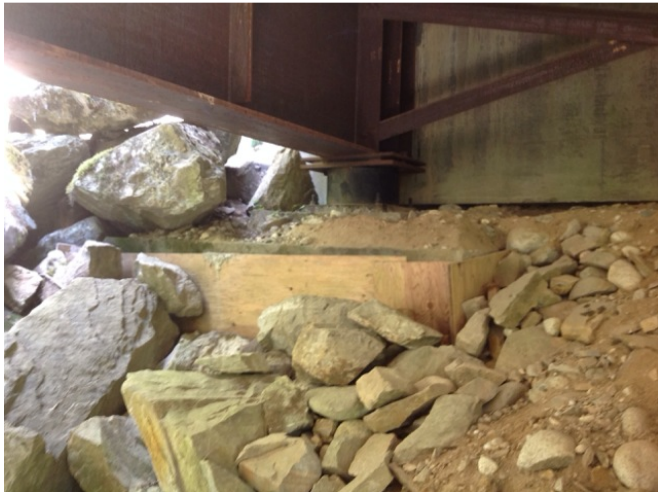
Concrete Fair left upstream pad has been casted below to help from erosion - appears to be holding up well

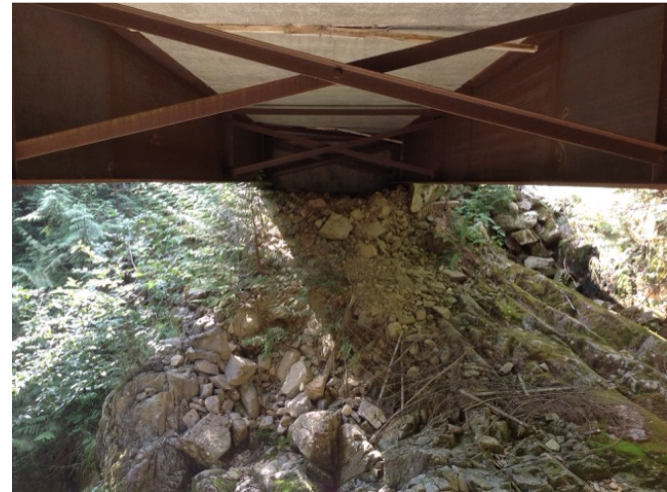
Right Bank Abutment when facing downstream

Wing Wall Good only right approach

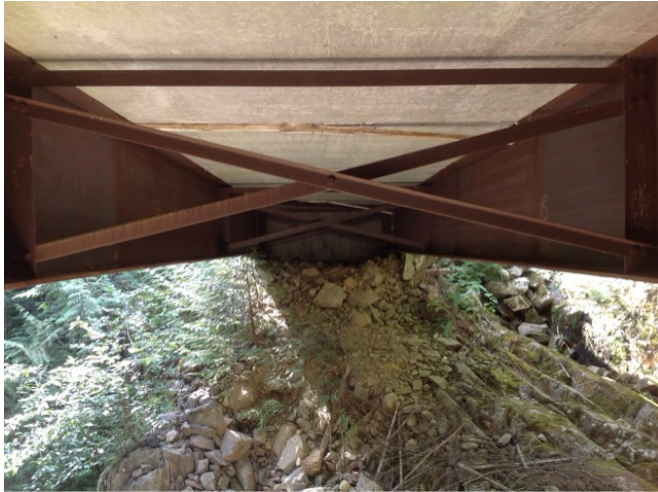
superstructure

Girders    Good            2 steel I beams

Diaphragms    Good            4 - bolted
