CK-2114

HARRISON EAST 56.5km

2014 Inspection

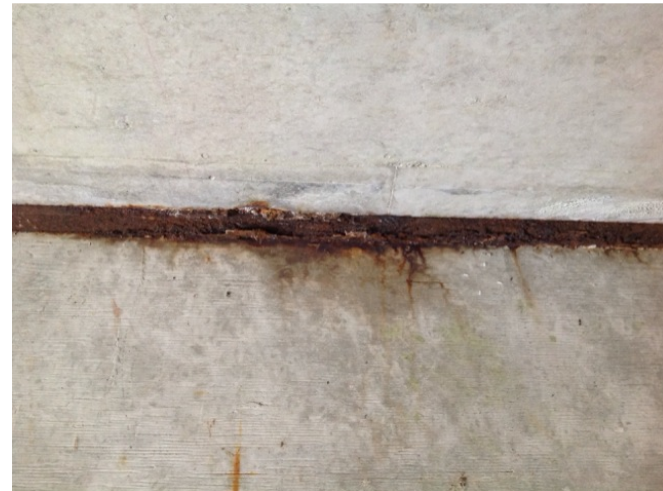
Grout Pockets    Fair

rusting girder at grout pockets

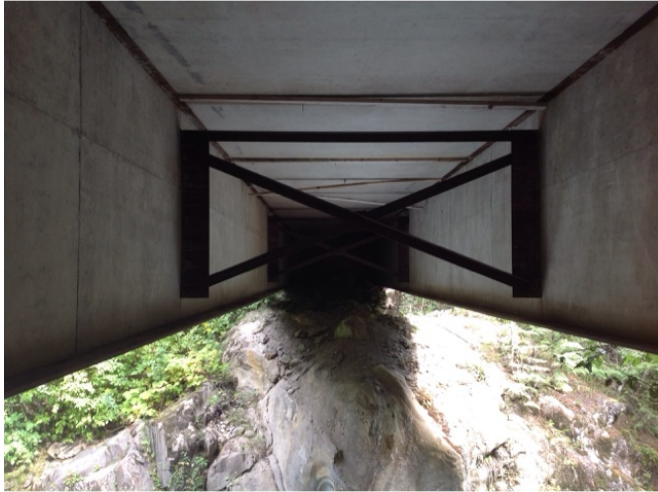
superstructure

Girders Fair 2 composite I beams - some hairline cracks noted

| 1 | hairline cracks in girders | routine |
