CK-2117

COGBURN CREEK 3.4km

2014 Inspection

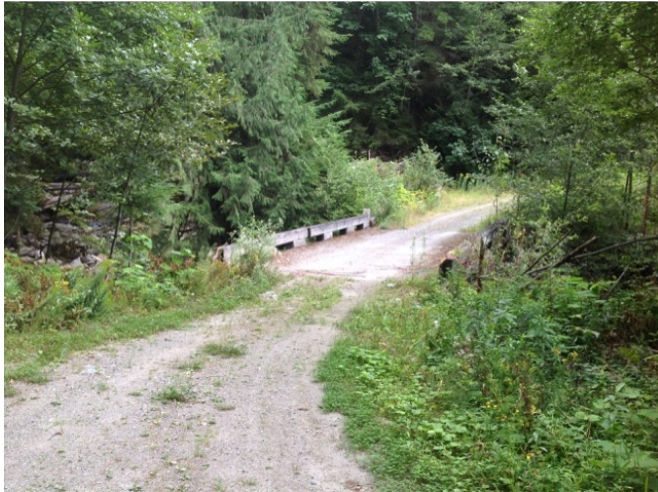
Approach from Right Bank when facing downstream

tight HC both approaches

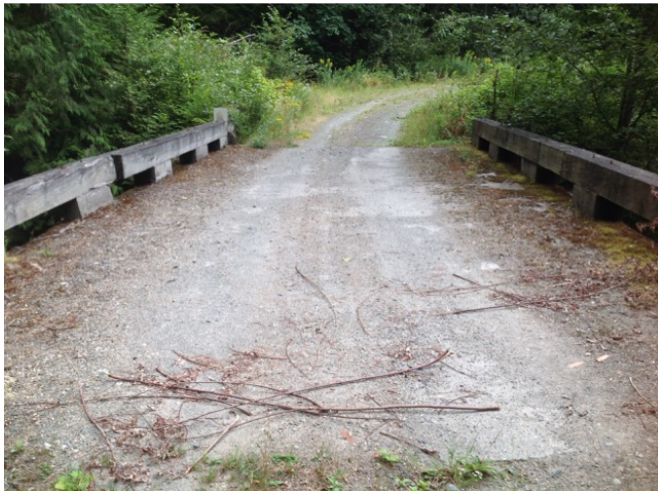
Curb Rail/Blocks/Posts Poor rotten

Hardware Poor loose rail bolts

Overall Deck Condition Poor due to rail

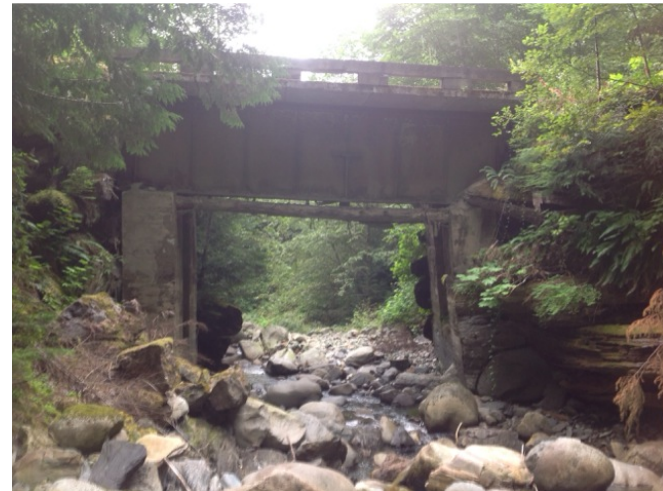
Upstream Profile

Girders Poor old riveted steel girders with different dimensions

| 1 | Medium | replace entire structure with activity |

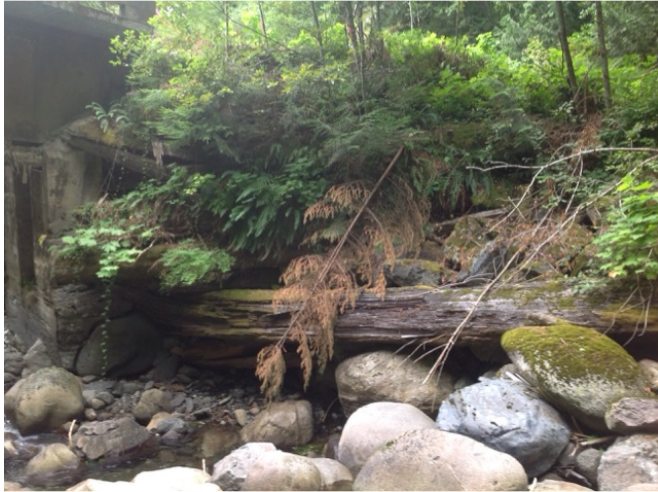
upstream right wing wall

rotten

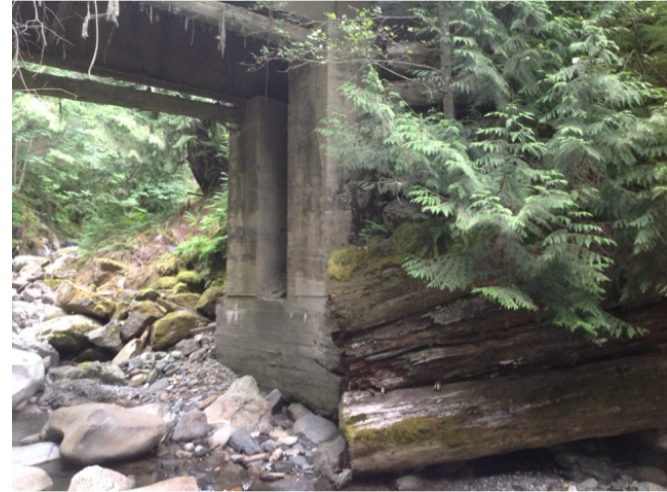
Left Bank Abutment when facing downstream

leaning, fractured

rotten logs

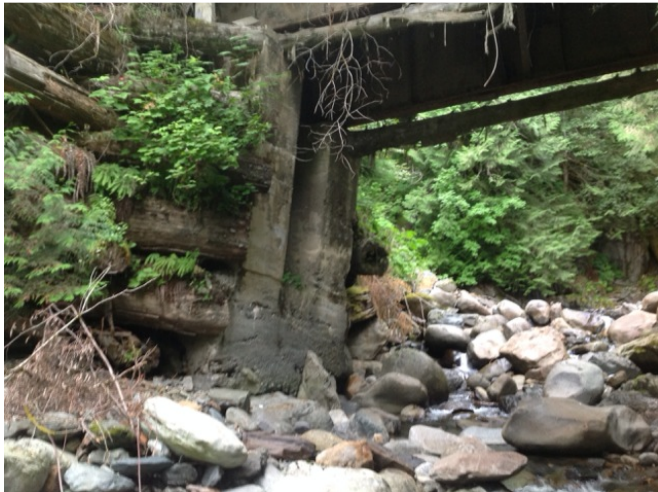
Right Bank Abutment when facing downstream

right bearing column is sloped into stream and steel does not bearing completely on concrete columns

not bearing completely
