CK-2120

BEAR CREEK 7km

2014 Inspection

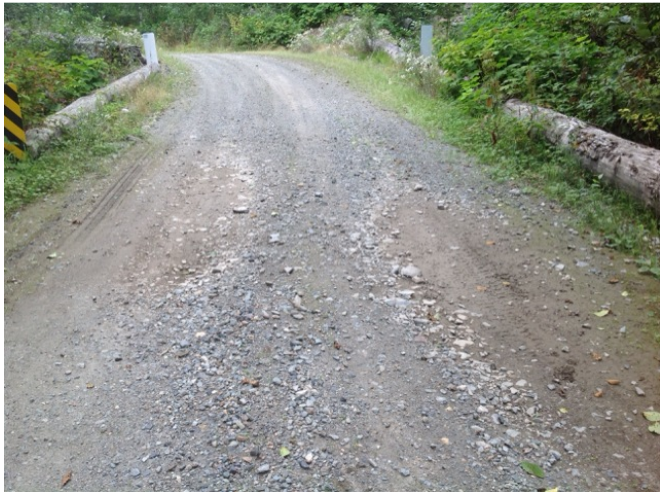
Gravel Surface Fair 600mm

Curb Rail/Blocks/Posts Poor not attached to stringers

Overall Deck Condition Poor due to rail
