CK-2121

BEAR CREEK 7.4km

2014 Inspection

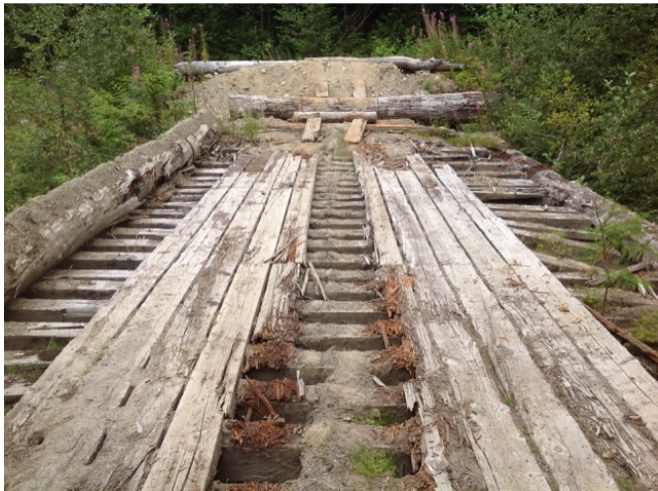
Overall Deck Condition Poor rotten

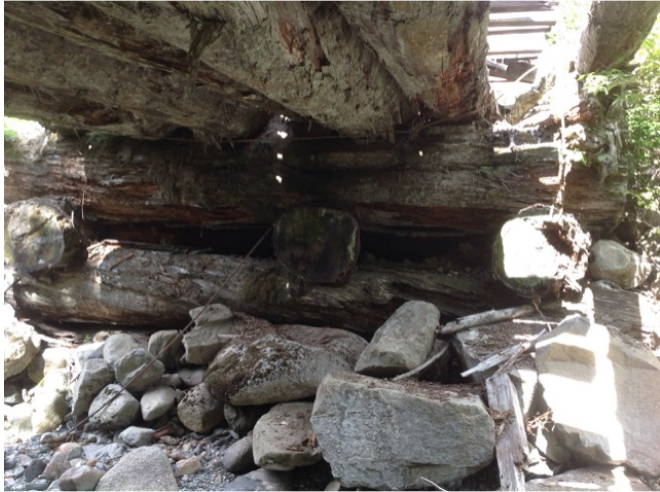
Right Bank Abutment when facing downstream

Log/Timber Cribs Poor rotten
