CK-2124

SHOVEL CREEK 2.9km

2014 Inspection

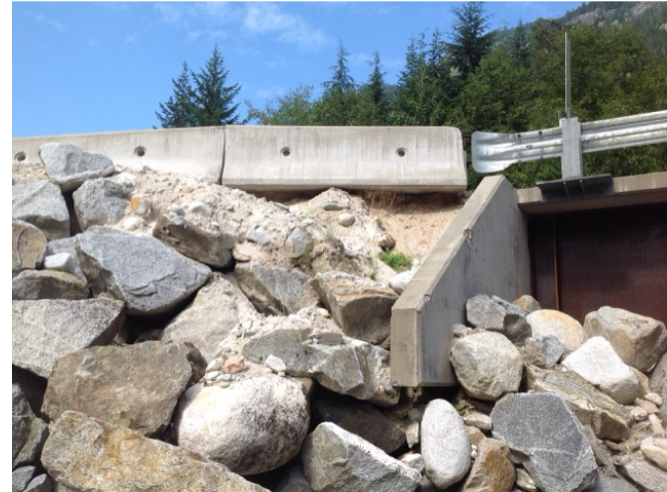
Monitor left upstream road approach for fill erosion and riprap scour. Present load rating of BCL-625 or 64 tonnes to continue.

fill erosion under left upstream concrete barriers

1 left approach upstream riprap and fill erosion

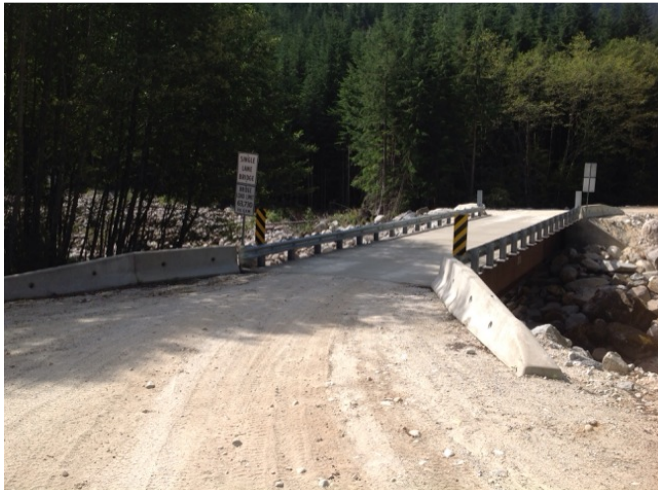
Approach from Right Bank when facing downstream

tight HC right approach
