CK-2129

STS'AILES 12.5km

2014 Inspection

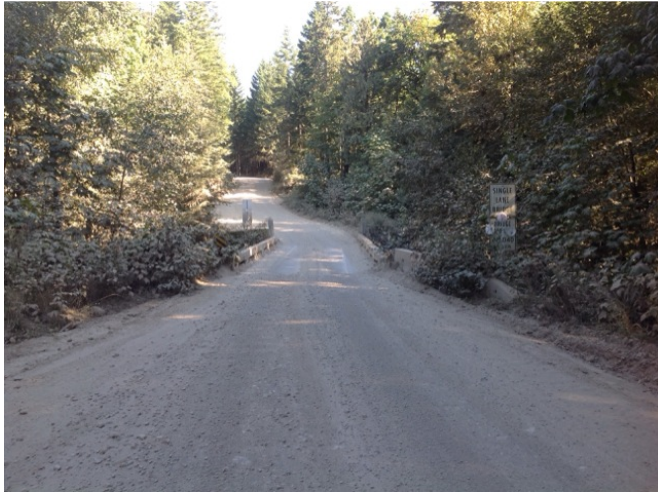
Approach from Right Bank when facing downstream

Delineator Missing  
Left ☒ 0 ☐ 1 ☐ 2Delineator Missing  
Right ☐ 0 ☒ 1 ☐ 2

| Repair Item | Priority | Repair Description |
|---|---|---|
| 2 | Medium | replace missing delineator |

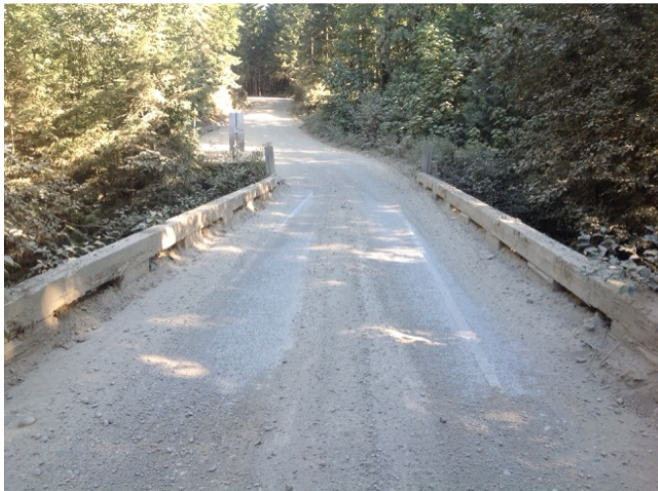
Running Surface Fair lots of sediment on deck

Concrete Deck Fair

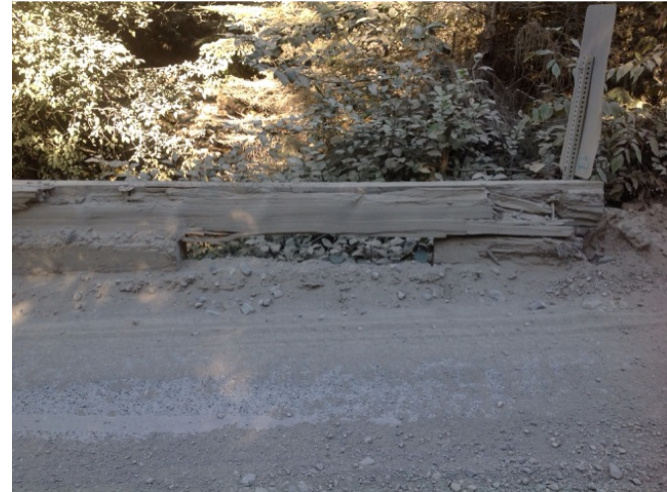
Guard Rail

Curb Rail/Blocks/Posts Fair replace damaged section

| Repair Item | Priority | Repair Description |
|---|---|---|
| 1 | Medium | replace damaged guardrail upstream left approach |

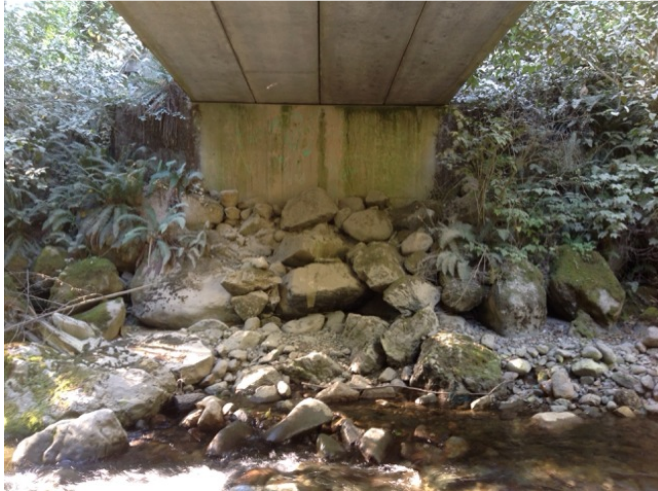
Right Bank Abutment when facing downstream

Concrete Good CIP both sides

Caps or Sills Fair rubber pads

Ballast Wall Fair timbers
