CK-2134

STS'AILES 23.5km

2014 Inspection

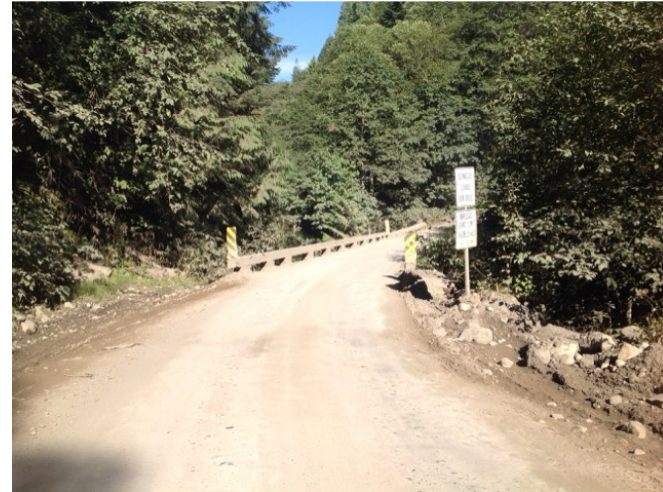
Approach from Right Bank when facing downstream

none on right approach

| Repair Item | Priority | Repair Description |
|---|---|---|
| 2 | Medium | replace missing delineator and add log fenders on right approach |

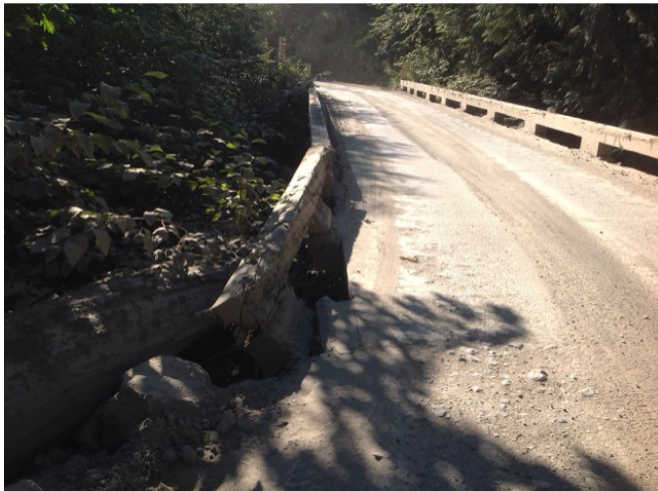
Guard Rail

| Curb Rail/Blocks/Posts | Poor | due to left approach downstream guardrail damage |

| Overall Deck Condition | Poor | due to guardrail damage |

| Repair Item | Priority | Repair Description |
|---|---|---|
| 1 | Medium | replace damaged guardrail |

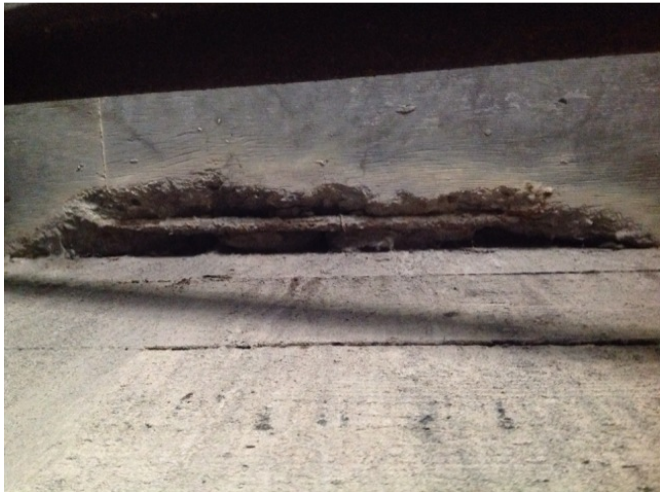
damage under panel 1

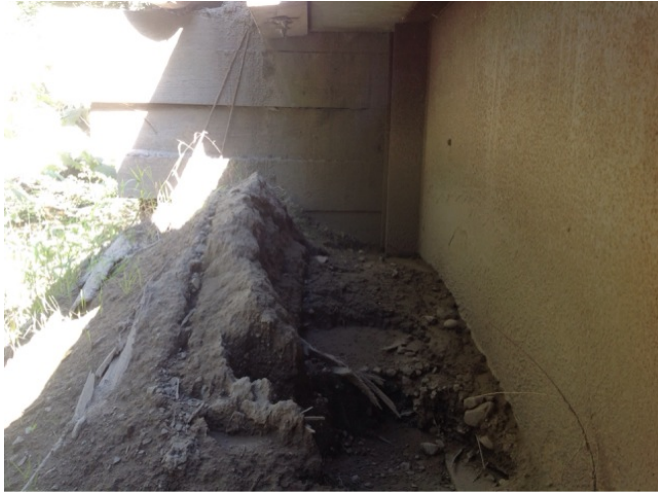
sediment is covering bearing plates on outside of girders on left abutment

sediment covering bearing on left approach

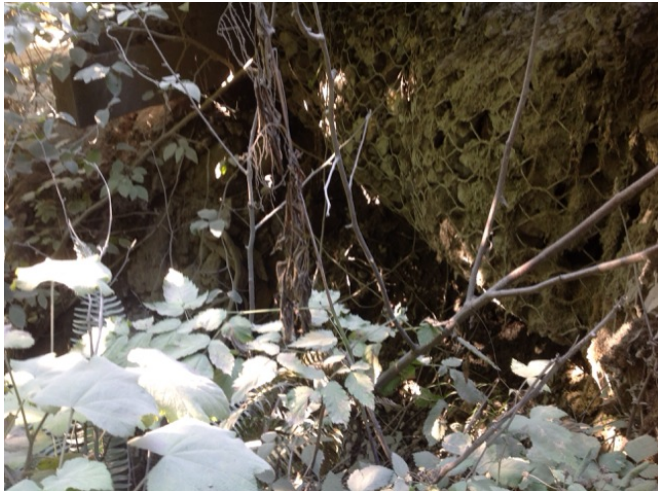
fair to poor as fill eroding underneath wall on left downstream

erosion right upstream approach and left downstream under fill retention system

fill erosion left downstream approach under fill retention system

1 fill erosion noted, especially under left downstream fill retention system
