CK-2138

STS'AILES 34.5km

2014 Inspection

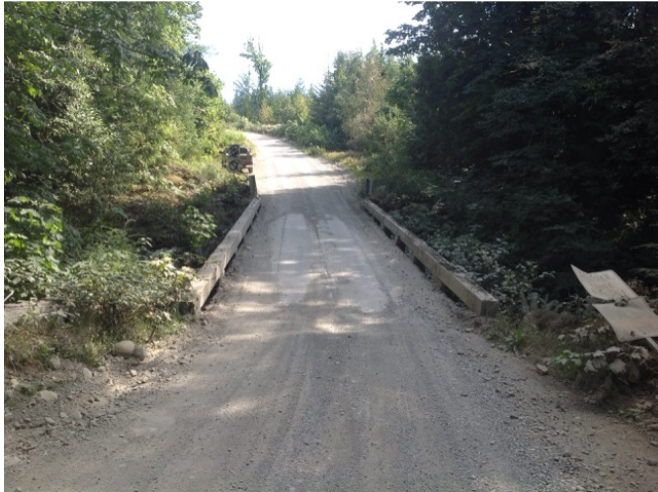
Approach from Right Bank when facing downstream

heavy VC and HC right approach

Delineator Missing  
Left ☐ 0 ☒ 1 ☐ 2Delineator Missing  
Right ☐ 0 ☒ 1 ☐ 2Fender Condition poor replace missing fenders

| Repair Item | Priority | Repair Description |
|---|---|---|
| 2 | Medium | replace missing delineators |
| 3 | Medium | replace missing log fenders |

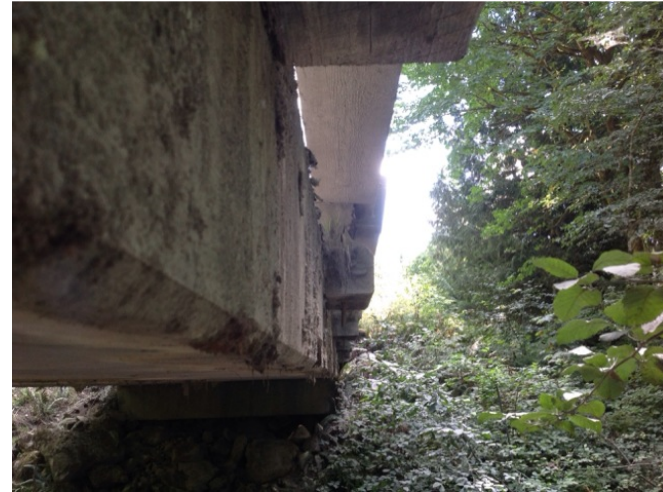
Guard Rail

Curb Rail/Blocks/Posts Poor rotten sideblocks and risers

Hardware Poor loose rail bolts

Overall Deck Condition Poor due to rail

| Repair Item | Priority | Repair Description |
|---|---|---|
| 1 | Medium | replace guardrail, risers and blocks |

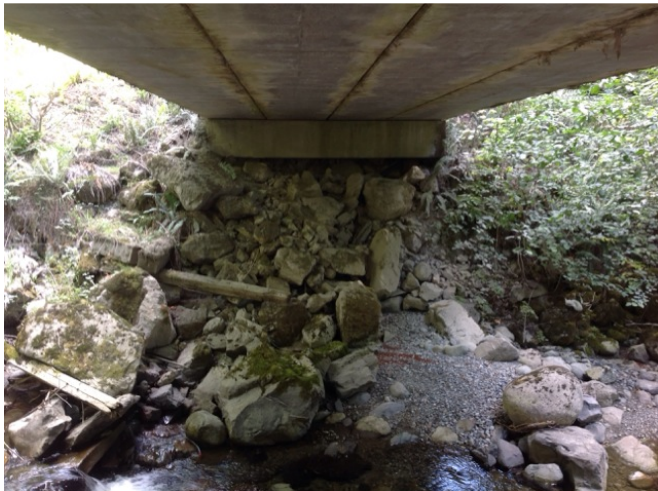
Left Bank Abutment when facing downstream

Riprap Fair - some scour noted - monitor

1 riprap scour
