CK-2139

STS'AILES 42km

2014 Inspection

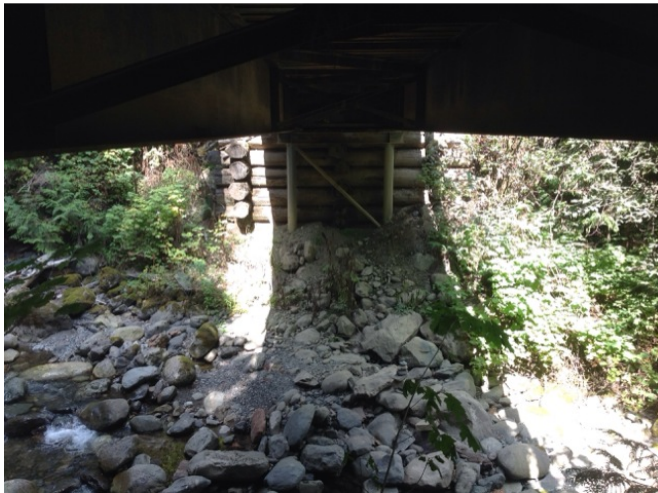
Left Bank Abutment when facing downstream

Bin Wall Fair left bank has crib retaining fill

Caps or Sills Fair steel I beam left, CIP right

Ballast Wall Fair treated timbers right, logs left

Fill Fair erosion left upstream road edge

Monitor left upstream erosion. Present load rating of L60 or 54 tonnes to continue.

1 fill erosion left upstream

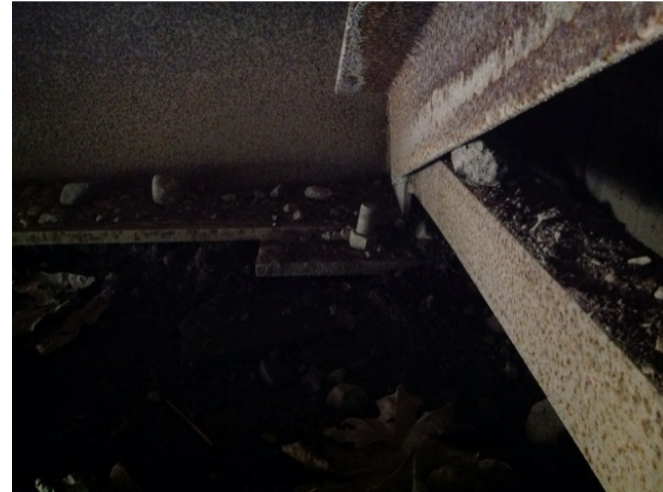
right downstream bearing bolt

Bearings Fair

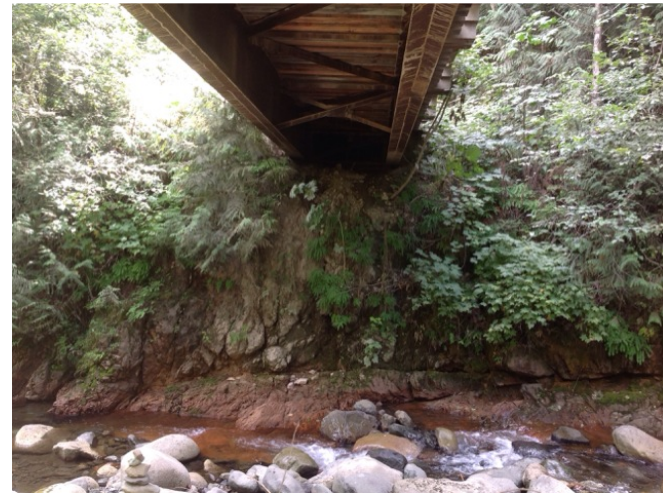
Right Bank Abutment when facing downstream

Concrete Fair right bank CIP

Riprap Fair BR right bank
