CK-2140

STS'AILES 46.5km

2014 Inspection

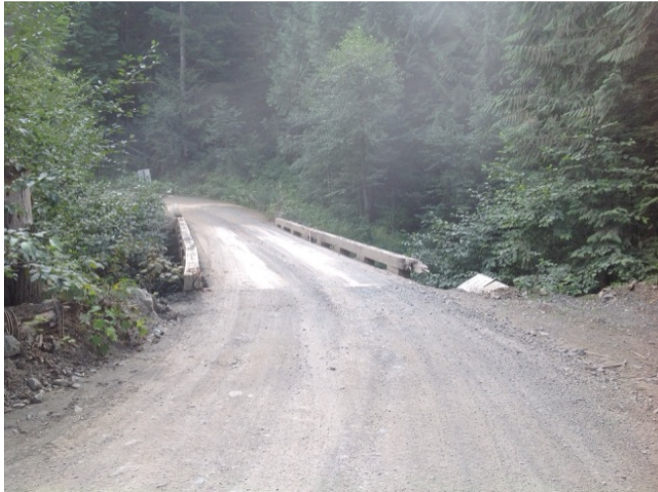
Approach from Left Bank when facing downstream

Alignment Fair fair to poor, HC both approaches

Delineator Missing  
Left ☐ 0 ☒ 1 ☐ 2

| Repair Item | Priority | Repair Description |
|---|---|---|
| 2 | Medium | replace missing delineators |

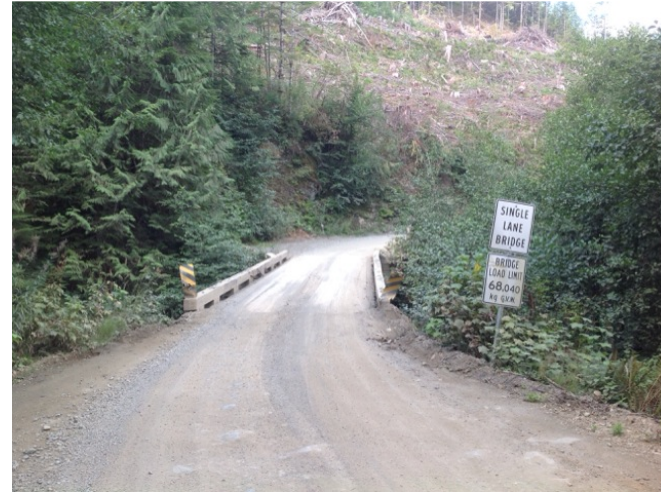
Approach from Right Bank when facing downstream

Delineator Missing  
Right ☐ 0 ☒ 1 ☐ 2

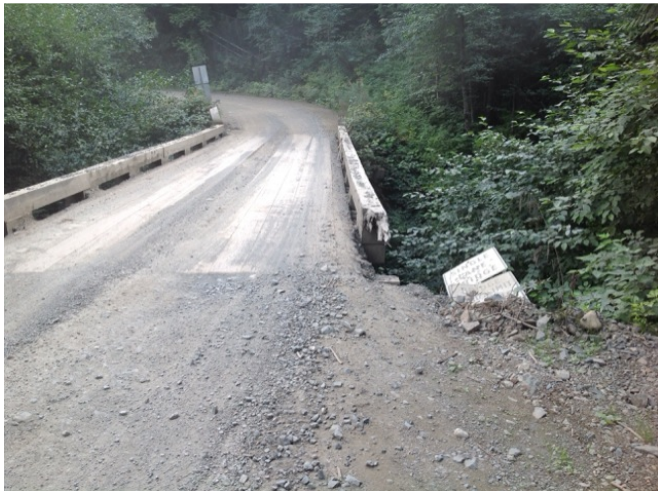
Guard Rail

Curb Rail/Blocks/Posts Fair small section damaged on left upstream end

| Repair Item | Priority | Repair Description |
|---|---|---|
| 1 | Medium | replace damaged guardrail section |

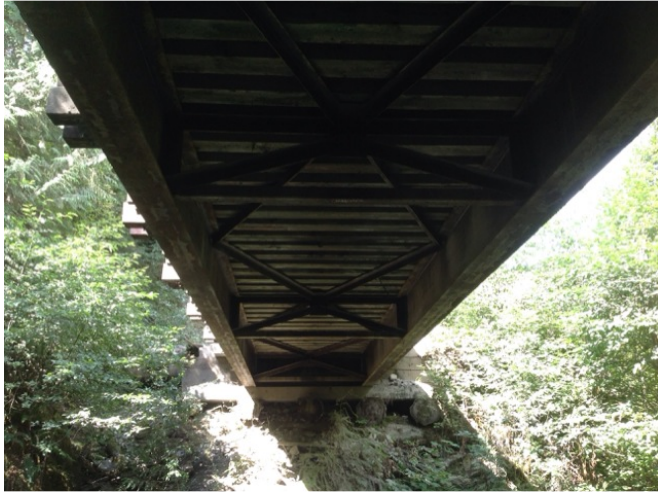
superstructure

| Girders | Fair | 2 steel I beams |
| Diaphragms | Fair | 4 bays, welded |

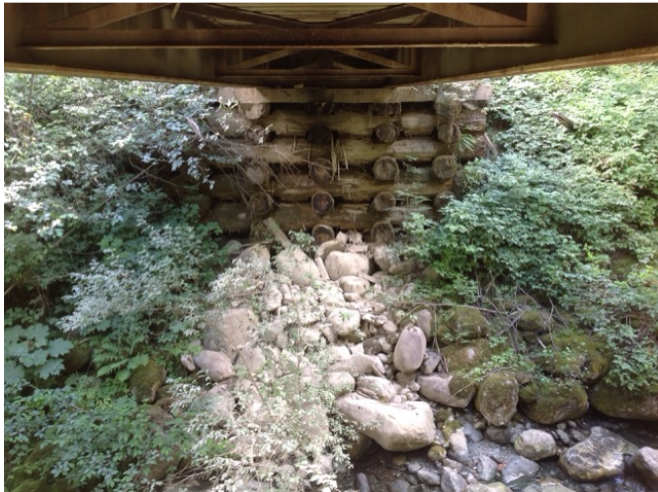
Right Bank Abutment when facing downstream

Log/Timber Cribs Fair 5x right bank
