CK-2141

STS'AILES 49.1km

2014 Inspection

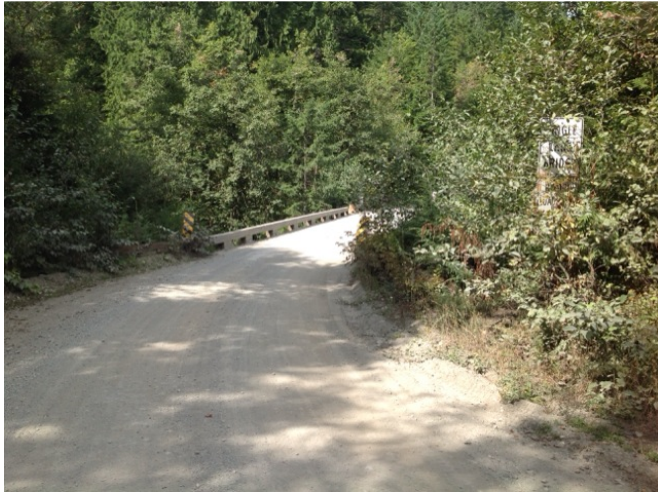
Approach from Right Bank when facing downstream

HC both approaches

Brushing Required Y

Brush approaches and post bridge ahead signs. Monitor old crib on left bank - retaining fill. Present load rating of L150 or 136 tonnes to continue. Update load rating sign.

| 1 | Medium | brush out approaches |

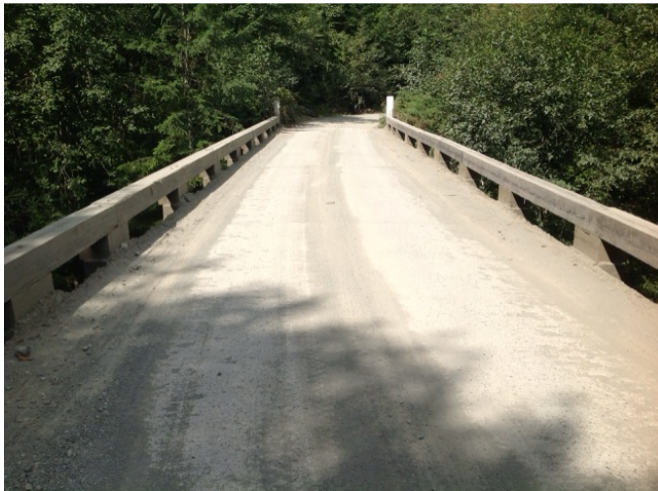
Overall Deck Condition Fair

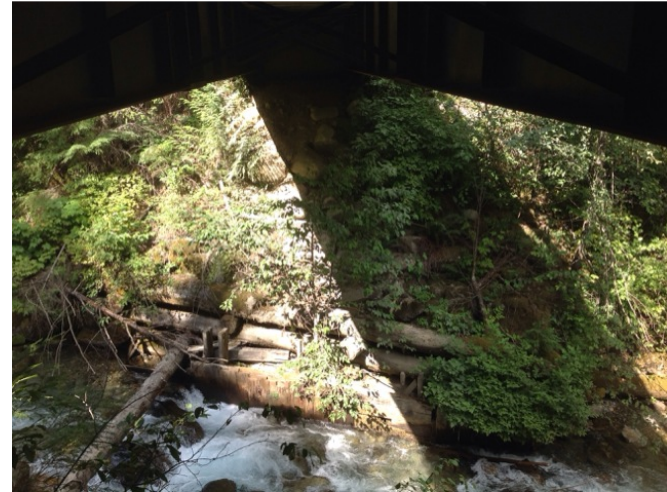
Left Bank Abutment when facing downstream

Bin Wall Fair log log crib on left bank holding fill

Caps or Sills Fair steel plates and rubber pads left

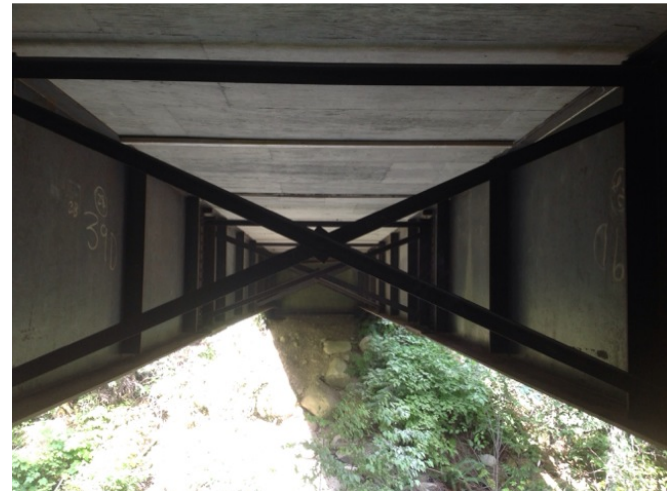
superstructure

| Girders | Good | 2 steel I beams - spliced |
| Diaphragms | Good | 5 bays, bolted |
