CK-2143

STS'AILES 55.4km

2014 Inspection

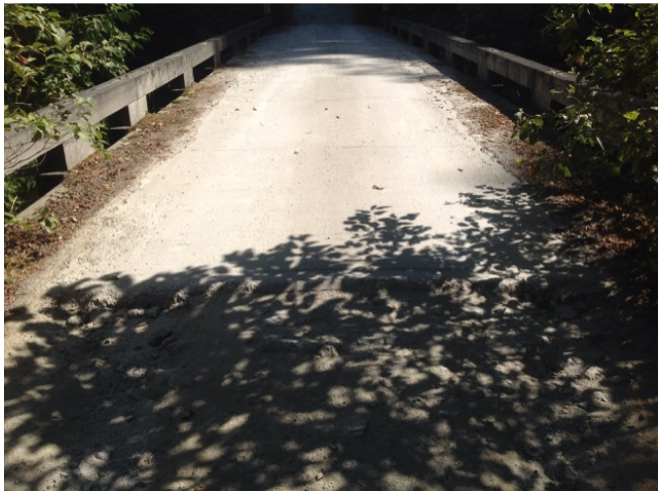
Ballast Wall Fair some wear at road surface

ballast wall damage at road surface

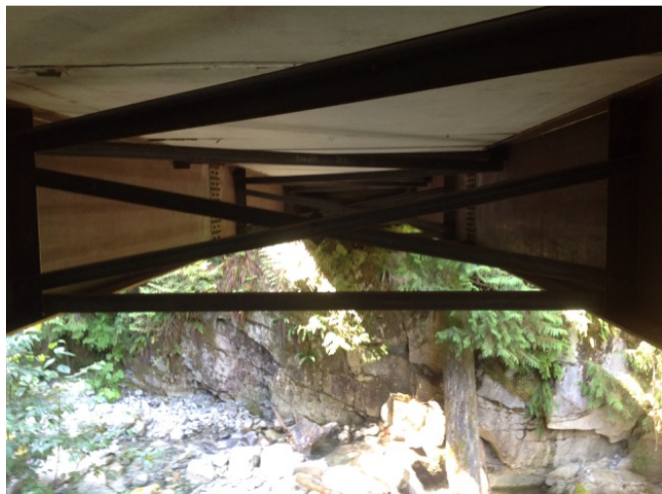
superstructure

Girders Good 2 steel I beams

Diaphragms Good 5 bays, bolted
