CK-2146

STS'AILES 64.4km

2014 Inspection

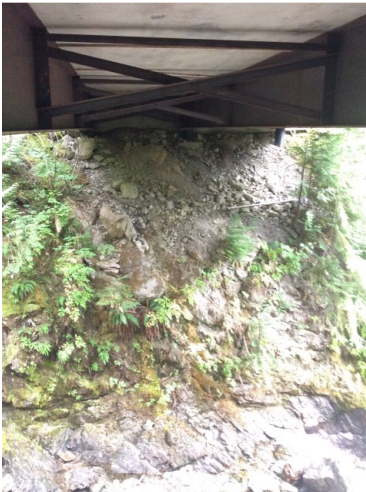
Left Bank Abutment when facing downstream

minor erosion under 1 locblock on each wing wall but likely there since a long time. no movement notes in blocks.
