CK-2154

JONES-WEST 0.6km

2014 Inspection

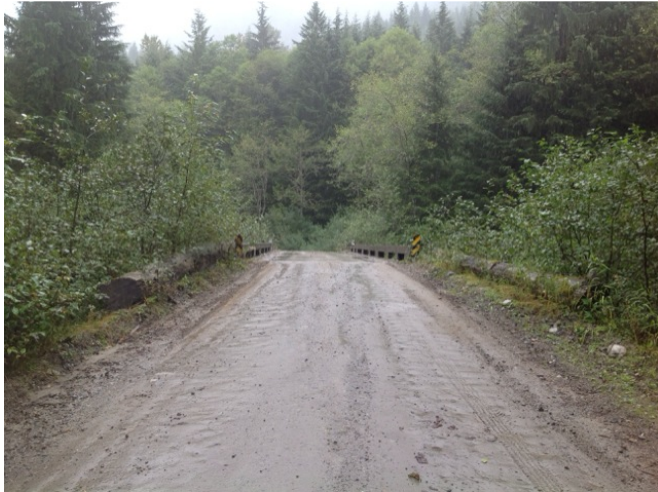
Approach from Left Bank when facing downstream

Bridge Ahead Signs  
Missing ☐ 0 ☐ 1 ☒ 2

Brushing Required Y minor

| Repair Item | Priority | Repair Description |
|---|---|---|
| 1 | Medium | post bridge ahead signs |
| 3 | Medium | brush |

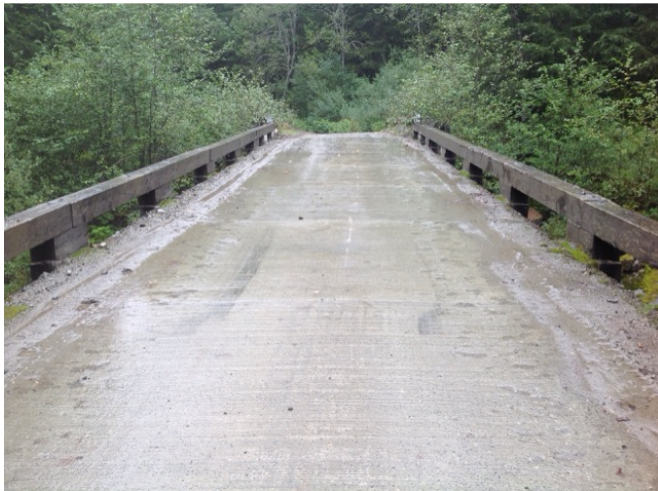
Concrete Deck    Fair

Curb Rail/Blocks/Posts    Poor    rotten blocks and risers

Hardware    Poor    loose rail bolts

Overall Deck Condition    Poor    due to rail

| Repair Item | Priority | Repair Description |
|---|---|---|
| 2 | Medium | replace guardrail, risers and blocks |

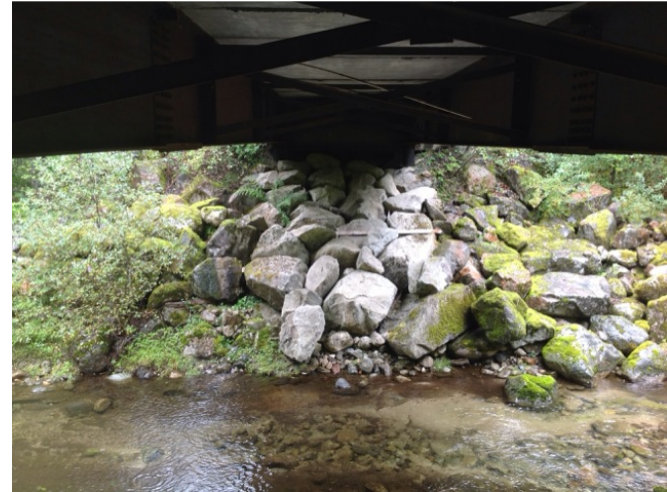
Right Bank Abutment when facing downstream

Ballast Wall Fair

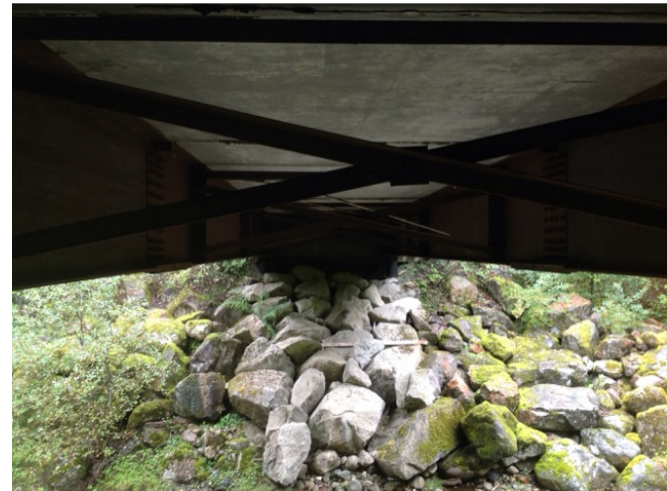
superstructure

Girders Good

Diaphragms Good 5 bays
