CK-2157

LORENZETTA HUNTER 2.2km

2014 Inspection

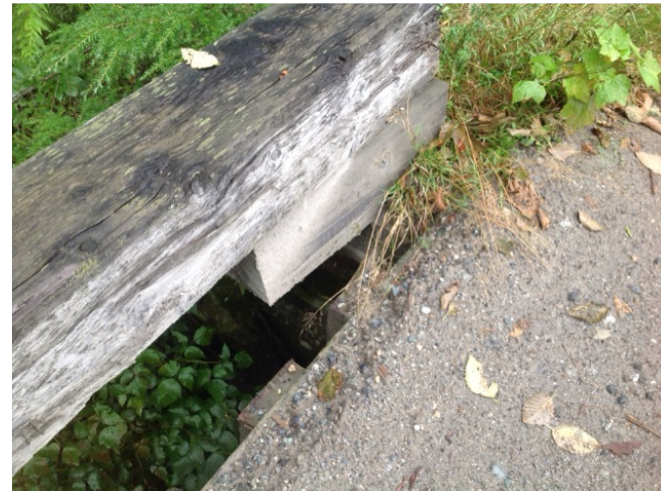
Curb Rail/Blocks/Posts Fair fair to poor as both end risers on left and right bank, upstream and downstream, are rotting and should be replaced along with slightly longer guardrail for better support

riser block only sitting on one tie

| Repair Item | Priority | Repair Description |
|---|---|---|
| 1 | Medium | replace both upstream and downstream end risers on both approaches along with first section of guardrail |

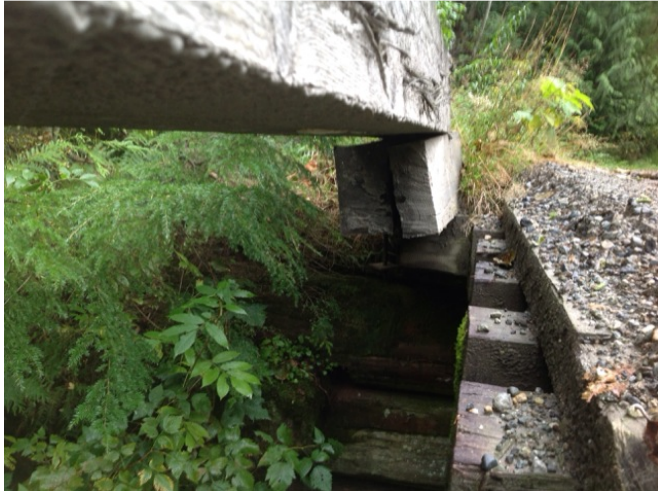
damaged riser block
