CK-2158

LORENZETTA HUNTER 4.9km

2014 Inspection

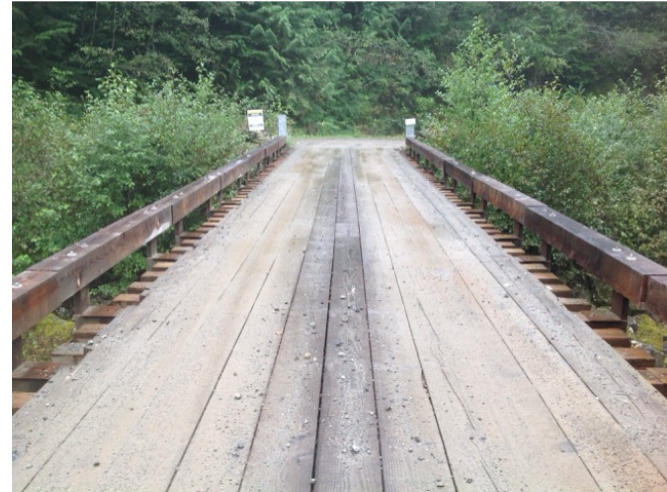
Deck to Girder Bolts Fair about 30% missing as holes in girders don't align with ties - originally designed for a modular deck and permanent deck installed - watched 2 loaded trucks go over and absolutely no movement of deck

Post bridge ahead signs and monitor deck. If any movement is noticed then recommend placing deck clips on remaining ties with risers attached to fasten deck. L75 or 68 tonnes load rating.
