CK-2163

LOST CREEK 1.1km

2014 Inspection

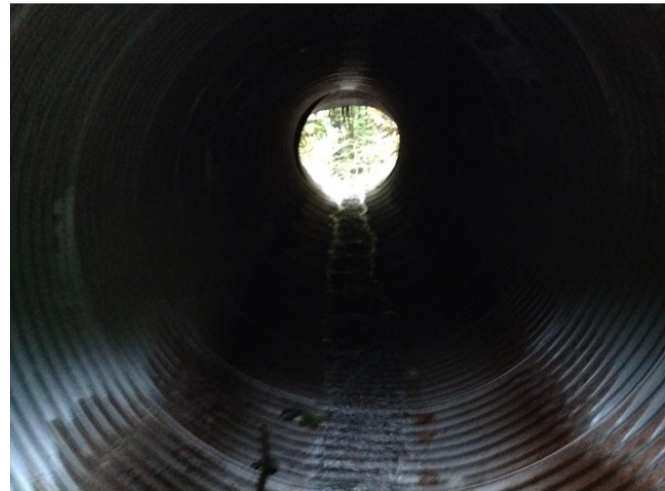
looking thru left culvert

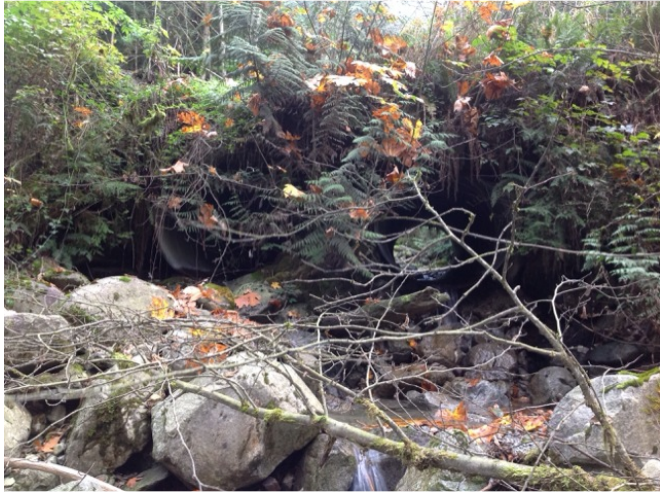
Outlet Poor 1.0m plunge pool and separating culvert

Comments 1.0m plunge pool at outlet  
5.0m stream width

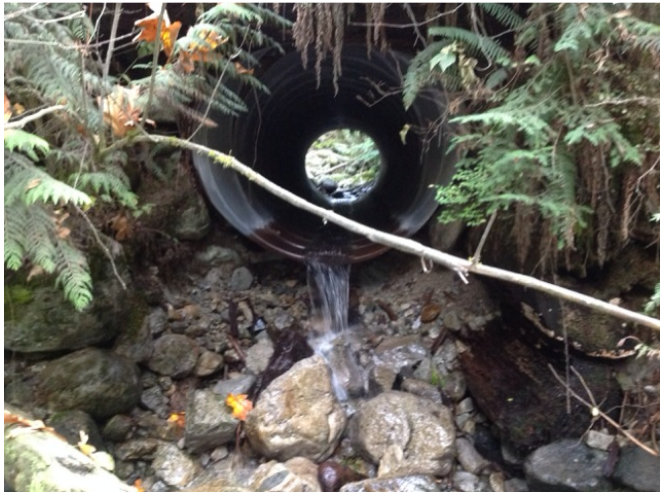
outlet of left culvert

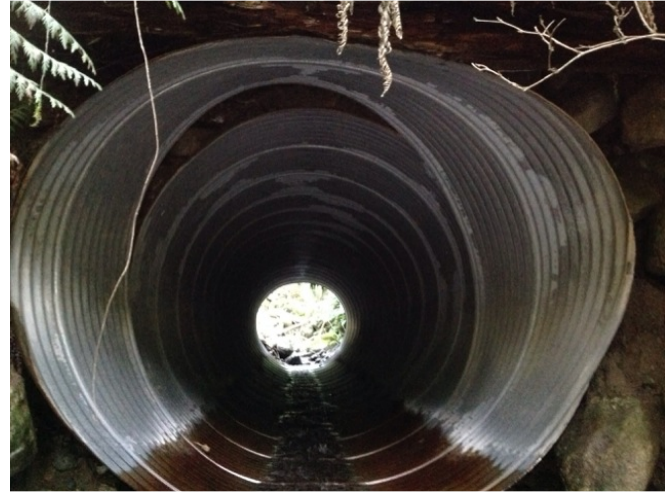
Culverts are separating due to settling dirt logs retaining fill. Either repair damaged sections of culverts (place culvert extensions at both the inlet and outlet) or replace entire structure. Monitor until such time the work is completed. Present load rating of BCL-625 or 63 tonnes to continue.

crushing and separating outlet

| Repair Item | Priority | Repair Description |
|---|---|---|
| 1 | Medium | repair separating outlet or replace entire structure |

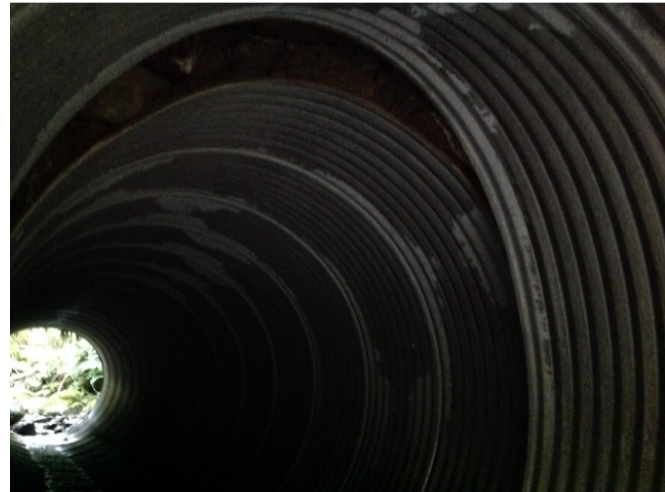
separating outlet

1 separating outlet
