CK-2167

LOST CREEK 8.4km

2014 Inspection

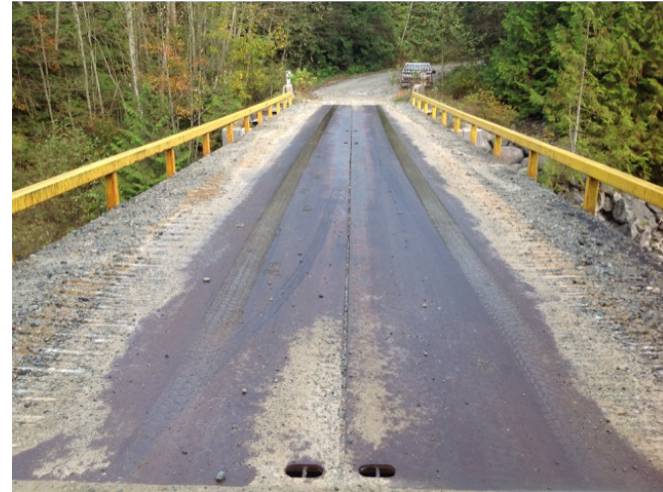
Steel Deck Plate Fair anti skid is worn off

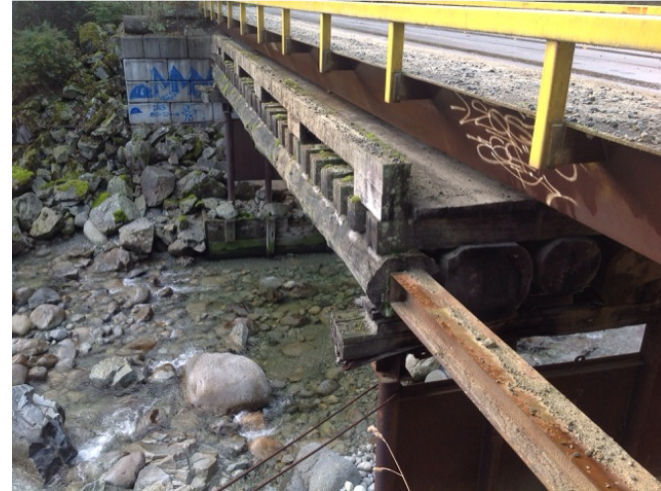
The old timber cap that is holding up the old stringers underneath the existing superstructure is rotting and crushing. I recommend removing the old log stringers and timber cap before failure. These items need to be monitored until removed. Present load rating of L75 or 68 tonnes to continue.

old structure underneath

| Repair Item | Priority | Repair Description |
|---|---|---|
| 1 | Medium | remove old structure underneath existing before failure due to rotten crushing timber caps |

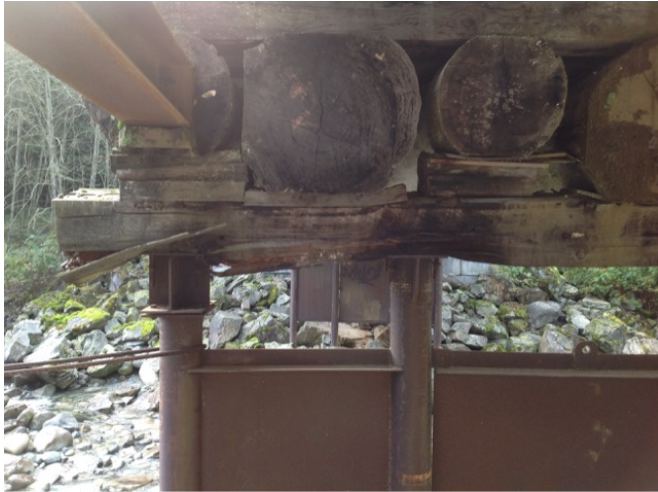
2 x 200mm x 200mm x 6096mm long - rot detected but not crushing. Old timber cap is rotten and crushing - should be removed

old structure timber cap crushing

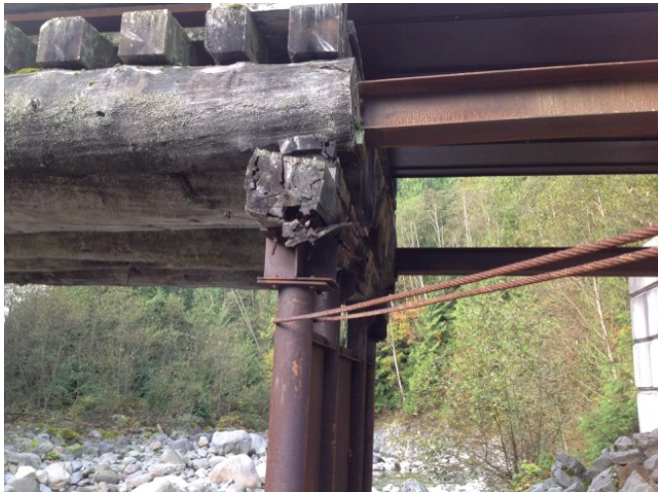
old structure timber cap rotten and crushing

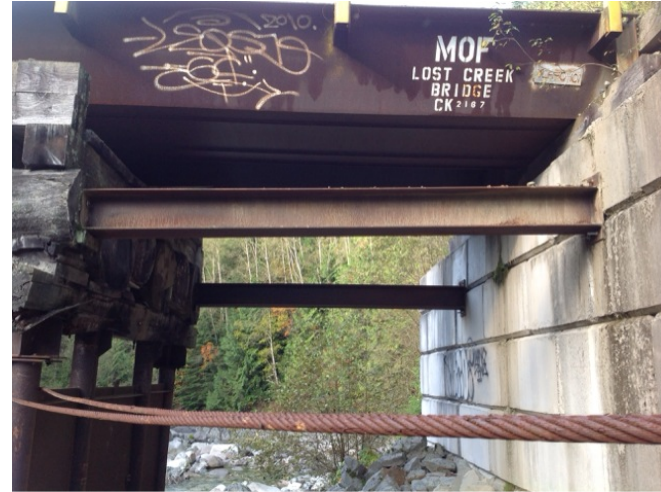
lock blocks still vertical and not moving with settling old structure which is tied to lockblocks

old log stringers fastened to lock block abutments

1 log structure for failure especially since they are fastened to lock block abutments
