CK-2171

LOST CREEK 17.8km

2014 Inspection

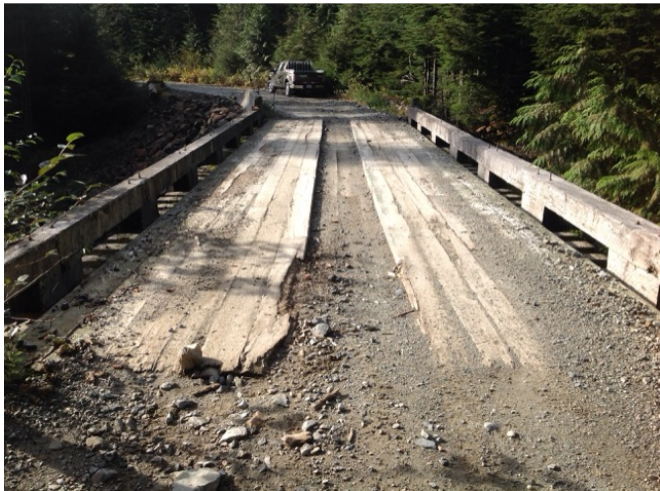
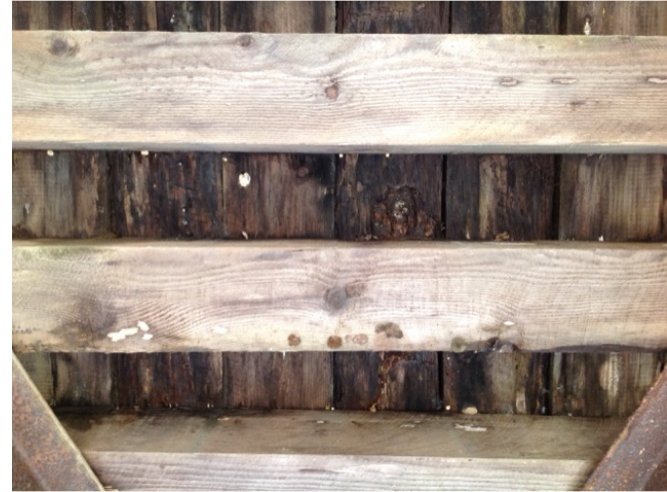
The running planks, sub deck and guardrail are all showing signs of decay. The ties are 8 years and are now also showing signs of decay. This deck assembly is untreated and the running planks are not required with the replacement work. Replace sub deck, ties and guardrail with activity. Post bridge ahead signs and replace missing delineators. The bearing plates on the girders do not bear properly on the bearing plates of the posts and recommend monitoring these. L45 or 41 tonnes load rating until deck replacement.

| Running Planks | Fair | fair to poor - will require complete replacement soon |
| Sub Deck | Fair | fair to poor as rot starting to accumulate underneath |

High - replace ties and subdeck (no running planks required with untreated deck

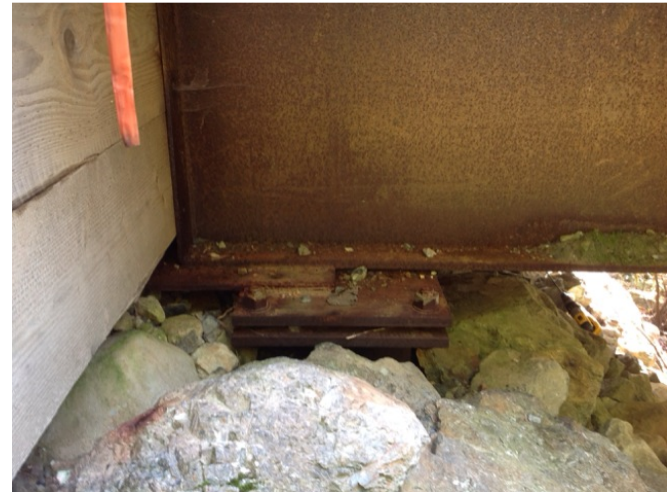
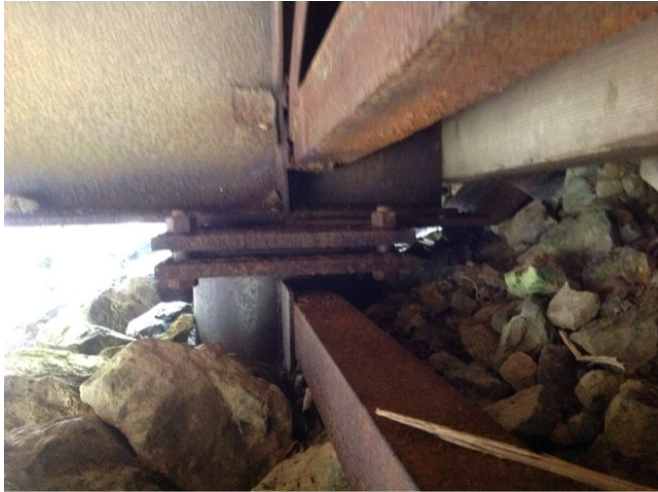
typical bearing

Bearings Fair check record drawings and structural drawings

Check bearing detail on structural drawings.  
Check age of deck as all showing signs of decay, running  
planks and subdeck especially.

bridge bearing

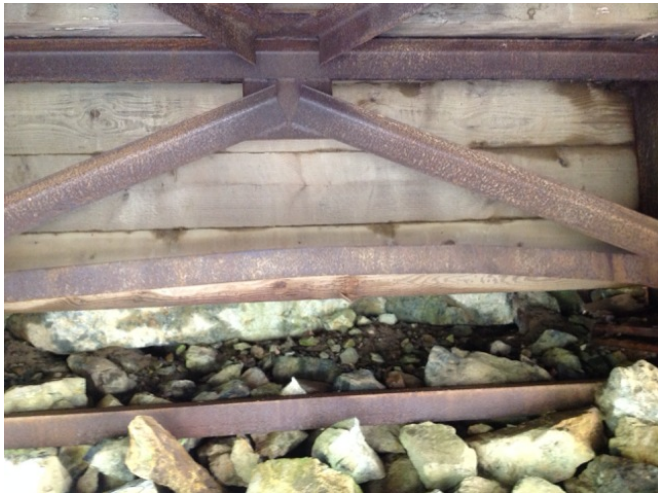
Diaphragms Fair welded - right abutment bottom cord bent

right abutment bottom cord on diaphragm
