CK-2172

LOST CREEK 18.8km

2014 Inspection

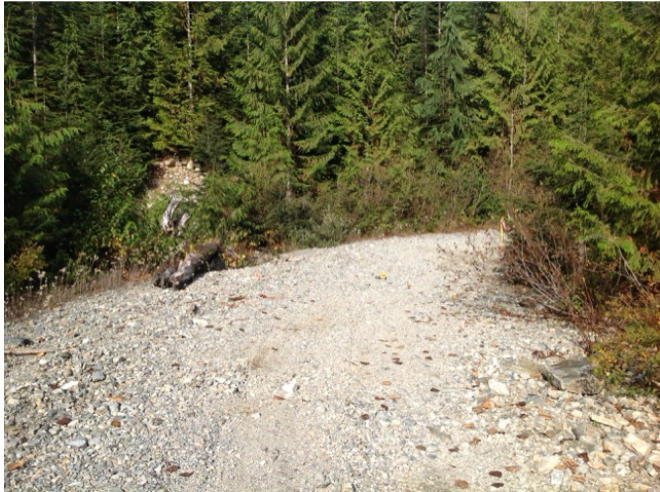
Approach from Right Bank when facing downstream

Alignment Fair

Road Surface Poor requires surfacing and grading

| 2 | road condition | Annually |

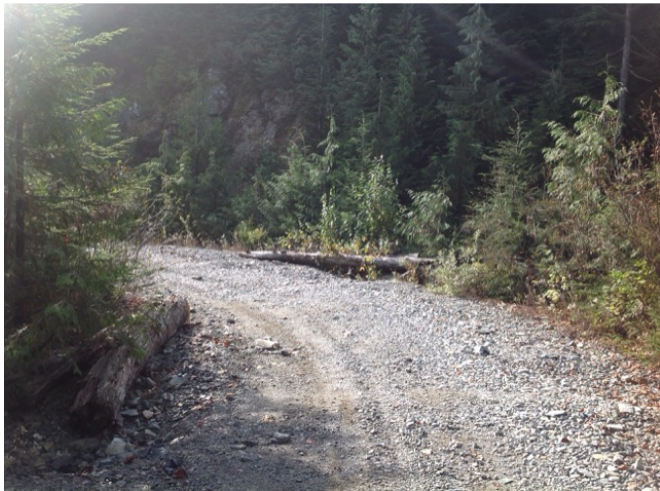
Approach from Left Bank when facing downstream

Posted Load Rating not posted

| Repair Item | Priority | Repair Description |
|---|---|---|
| 3 | High | post load rating sign |

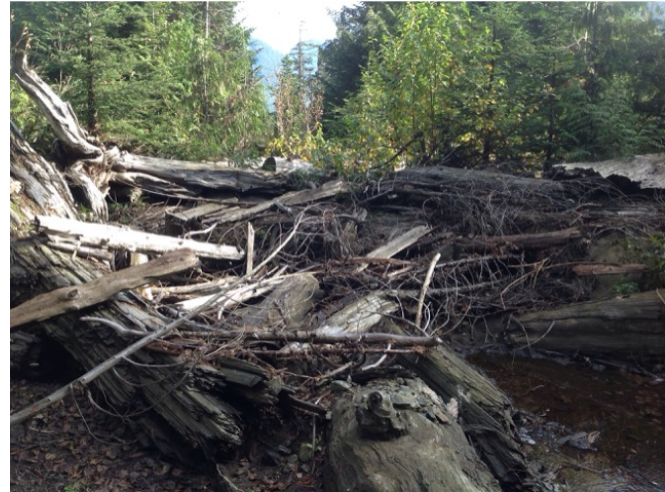
Inlet

The structure cannot be properly inspected - cannot access all log stringers. The inlet is completely blocked with debris and requires cleaning. Replace the entire structure prior to industrial activity. 10 tonnes load rating to continue. The road that accesses this structure is in extremely poor shape and requires maintenance. Post load rating sign.

| Repair Item | Priority | Repair Description |
|---|---|---|
| 2 | Medium | remove debris from inlet |

| 1 | debris buildup at inlet | Annually |
