CK-2174

LOST-MURDO 0.7km

2014 Inspection

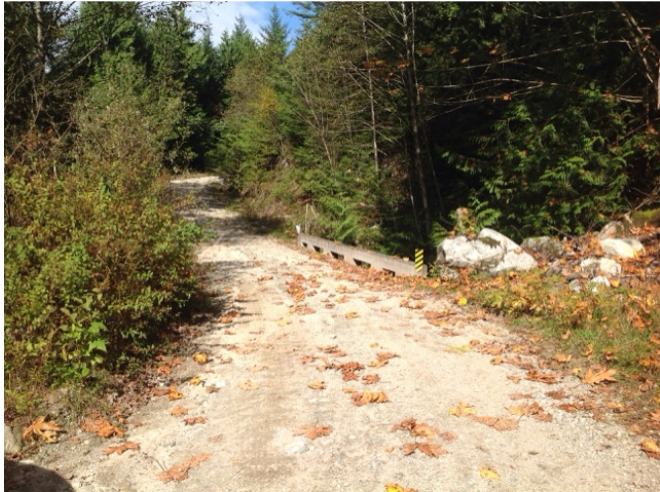
Approach from Left Bank when facing downstream

VC and HC on both approaches

Brushing Required Y

| 1 | Medium | brush approaches |

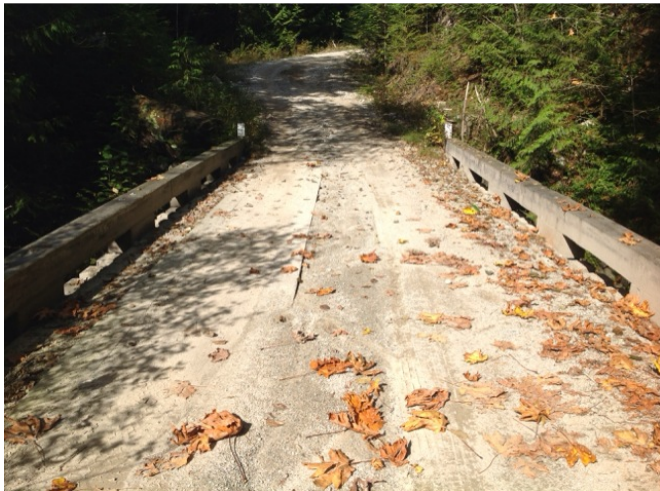
Running Surface N/A lots of sediment on deck

Overall Deck Condition Good

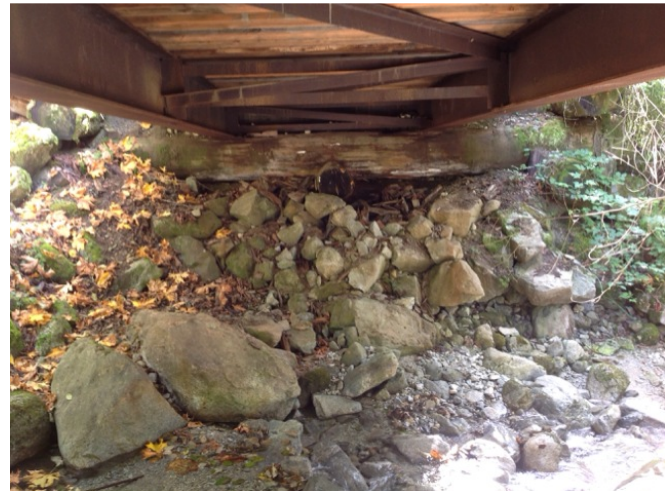
Left Bank Abutment when facing downstream

Log/Timber Cribs Fair

Riprap Fair slight scour downstream left bank

| 1 | scour | regular inspection frequency |

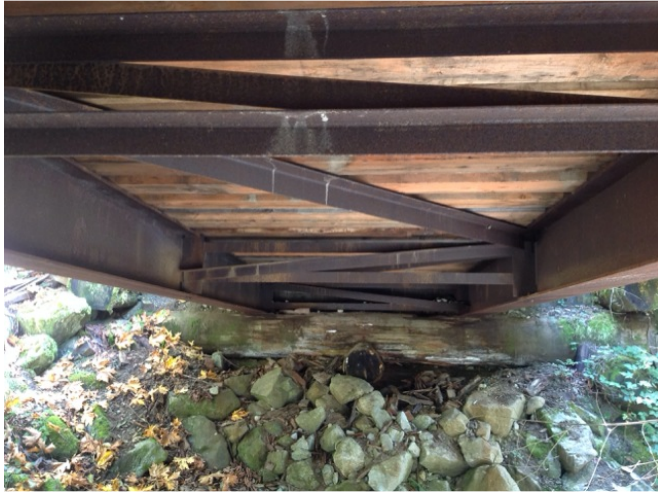
superstructure

Girders Fair shallow girders
