CK-2200

KOOKIPI CREEK 0.1km

2014 Inspection

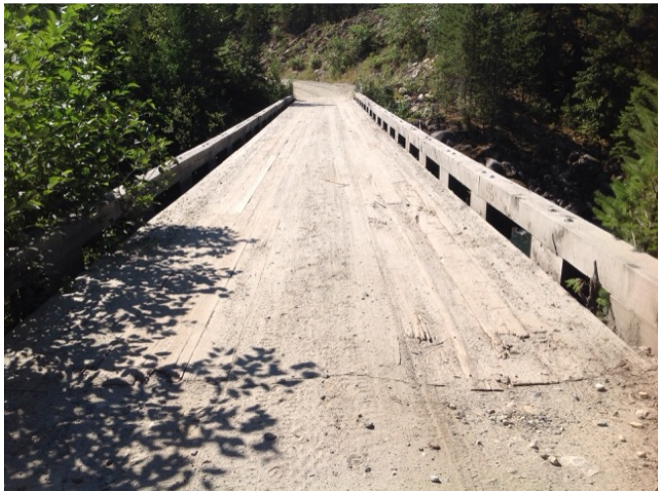
Deck

Running Planks Fair fair to poor as localized rot/wear apparent

Nails Fair fair to poor as some are protruding with worn planks

| Repair Item | Priority | Repair Description |
|---|---|---|
| 1 | Medium | recommend replacing running planks |

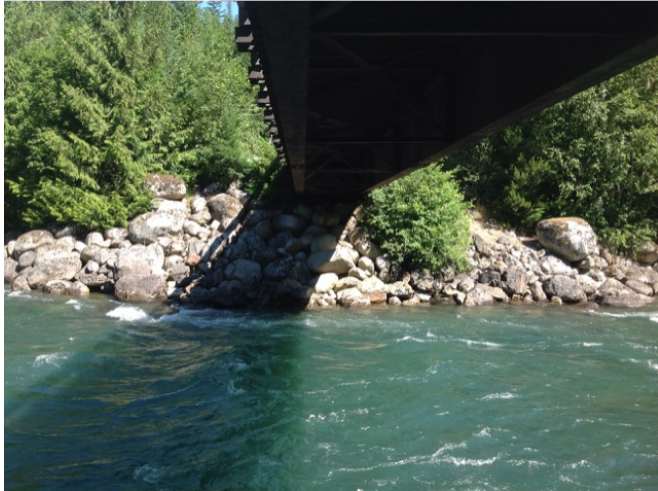
Left Bank Abutment when facing downstream

Ballast Wall Fair minor damage noted downstream left side, hairline cracks visible

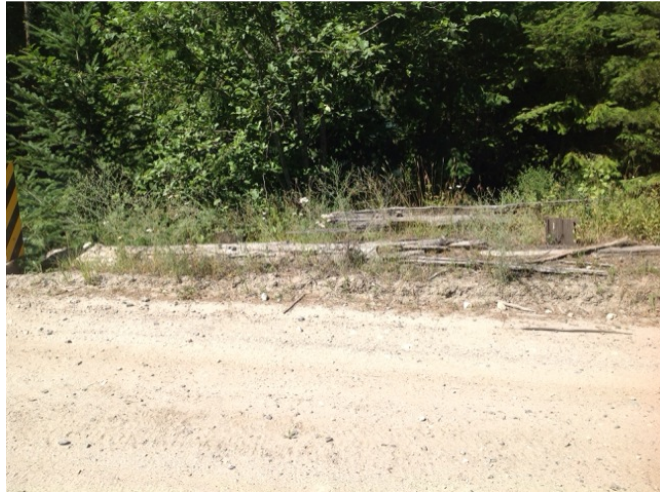
fender log

Fender Condition Poor old rotten logs

| Repair Item | Priority | Repair Description |
|---|---|---|
| 3 | Medium | replace fender logs |
