CK-2202

KOOKIPI CREEK 15.8km

2014 Inspection

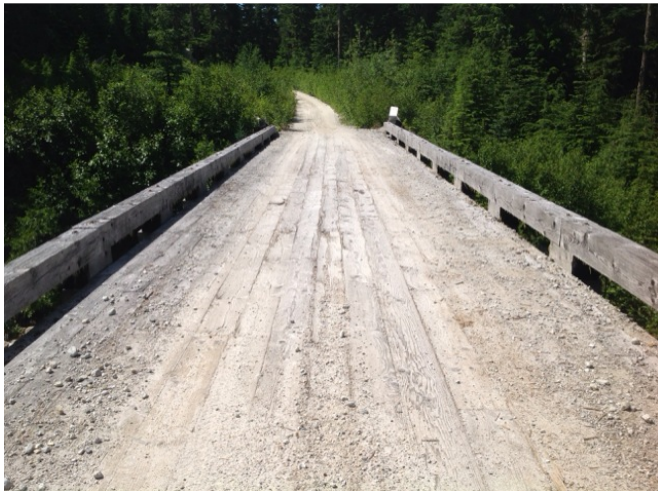
| Running Planks | Fair | fair to poor - replace with industrial activity |
| Curb Rail/Blocks/Posts | Poor | replace with industrial activity |
| Hardware | Poor | loose rail bolts |
| Overall Deck Condition | Poor | due to rotting rails |

| Repair Item | Priority | Repair Description |
|---|---|---|
| 1 | Medium | replace running planks and guardrail with activity |

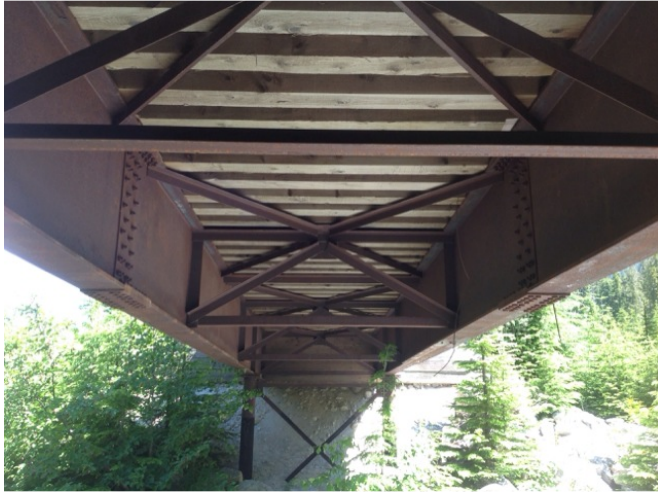
superstructure

Girders Fair steel beams, spliced and cantilevered from bearing
