CK-2204

NORTH AINSLIE CREEK 10.8km

2014 Inspection

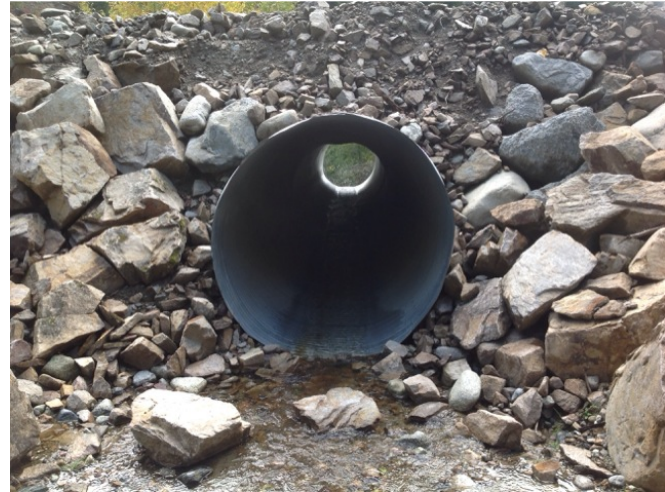
Inlet

Comments    structure is now an 1800mm CSP  
                 1.1m fill inlet  
                 1.3m fill outlet  
                 inspect with road inspections
