CK-2205

NORTH AINSLIE CREEK 17.4km

2014 Inspection

| Structure Class | Major Culvert |

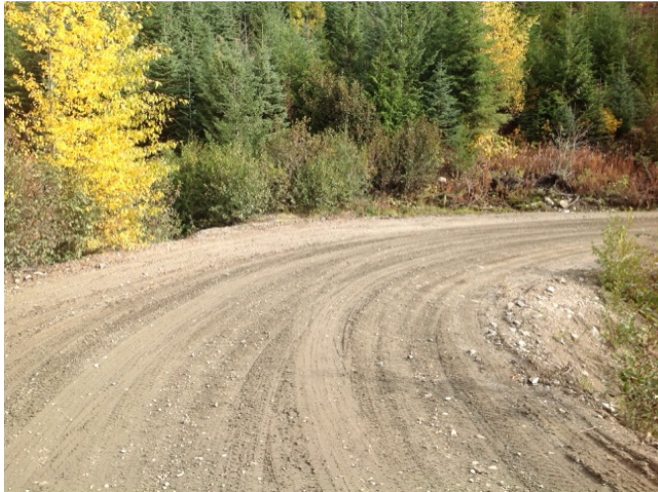
Approach from Right Bank when facing downstream

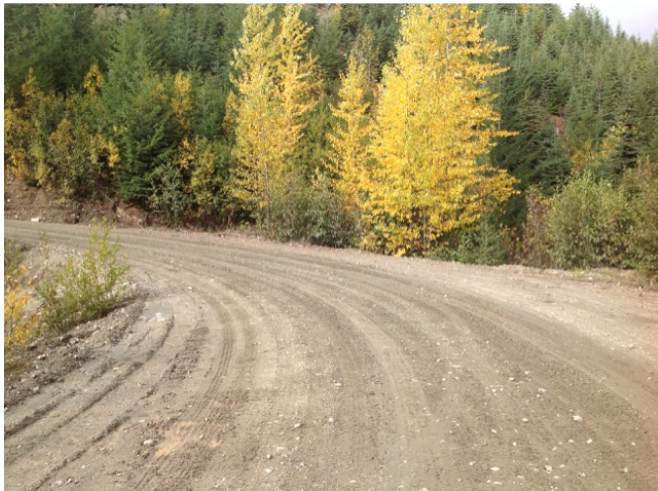
Approach from Left Bank when facing downstream

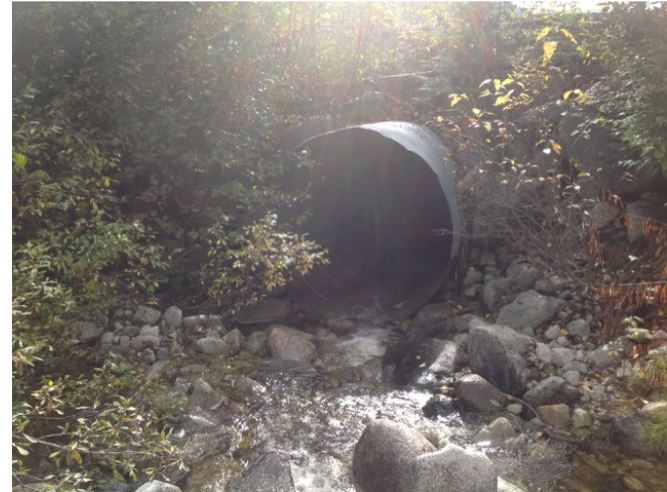
Inlet Good

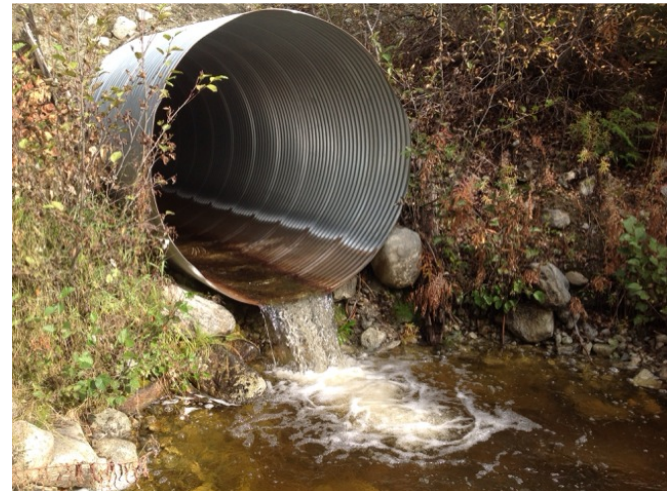
Outlet Fair 1.0m plunge pool
