CK-2207

MOWHOKAM 9.6km

2014 Inspection

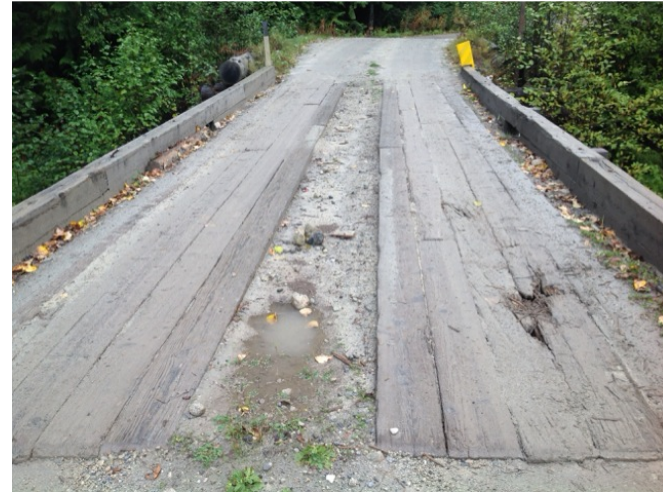
The deck condition continues to deteriorate, reduce loading to 30 tonnes. Post updated load rating sign and monitor the log stringers underneath for failure.

| Overall Deck Condition | Poor | due to plank and sub deck condition |

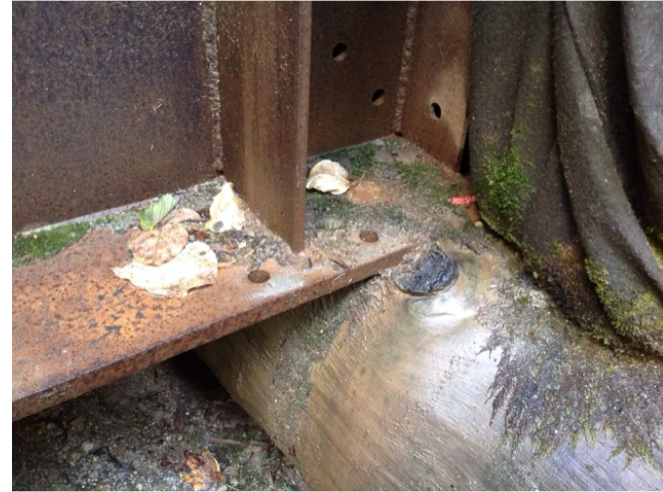
left downstream bearing

steel girders not connected to log sill

steel not square on log sill

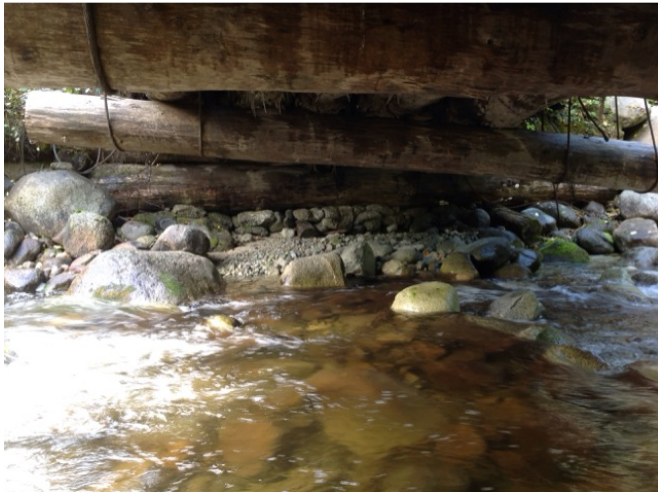
Left Bank Abutment when facing downstream

Log/Timber Cribs Poor

for fill retention

Tie Backs Poor

rotten

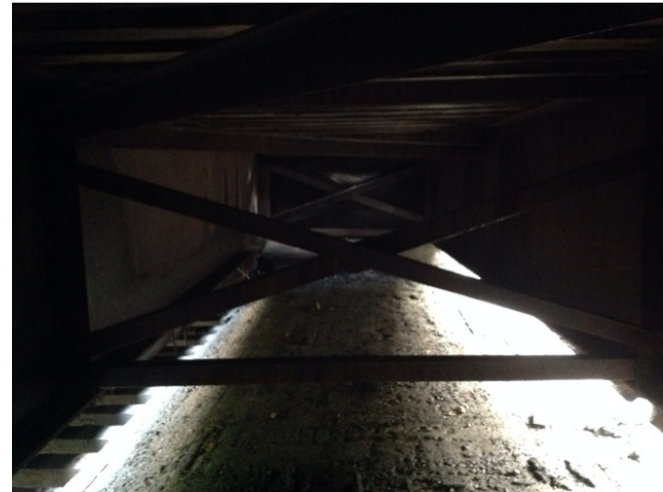
superstructure

Girders Fair only portion of 30.4m long steel girders

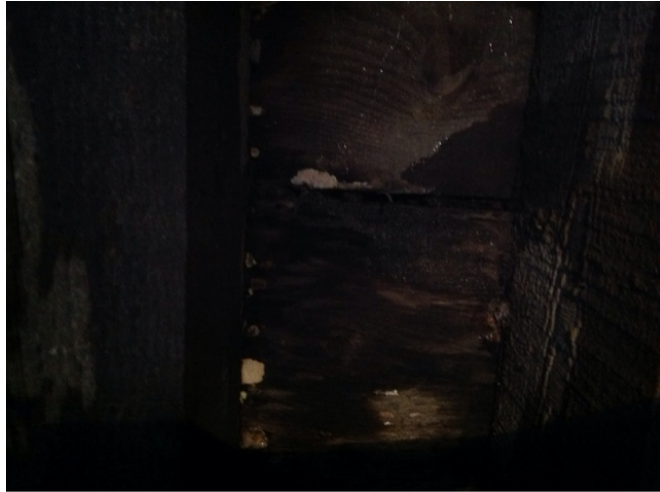
subdeck

| Sub Deck | Poor | rotting |

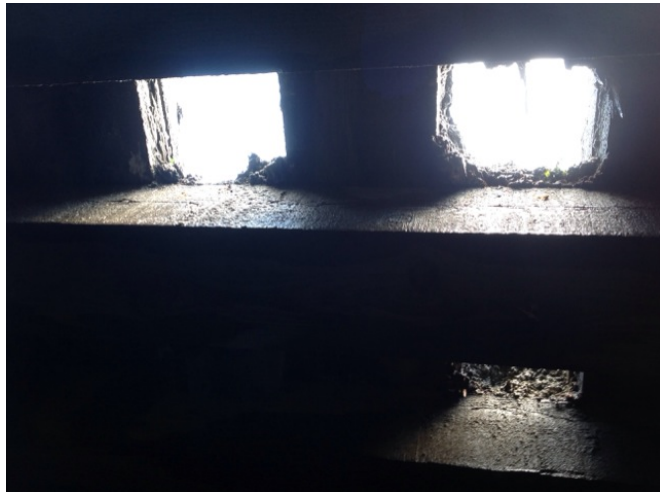
rotten subdeck
